EF-0 Hamlin Grove Tornado

September 1, 2016 at 8:38 pm

Public Information Statement

...Damage Survey for 09/01/16 Tornado Event...

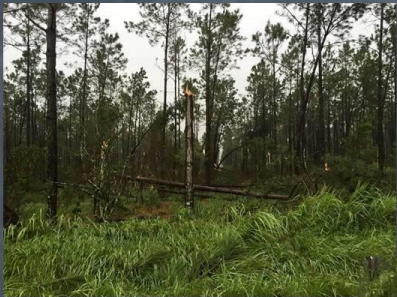
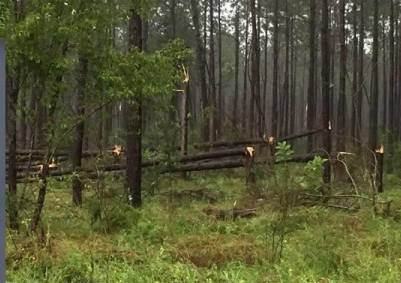
Damage reports included snapped trees, fences, a pool screen enclosure & damage from flying debris near Winter Garden.
