## June 9, 2010 Heavy Rainfall Event

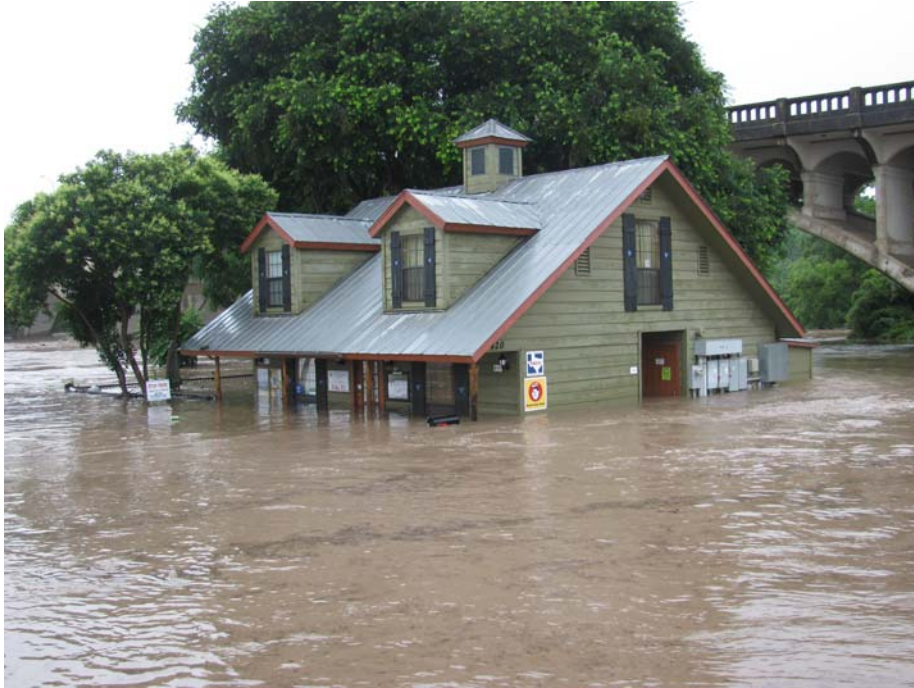
Photo 1, RV Park underneath I-35 bridge at the Guadalupe River

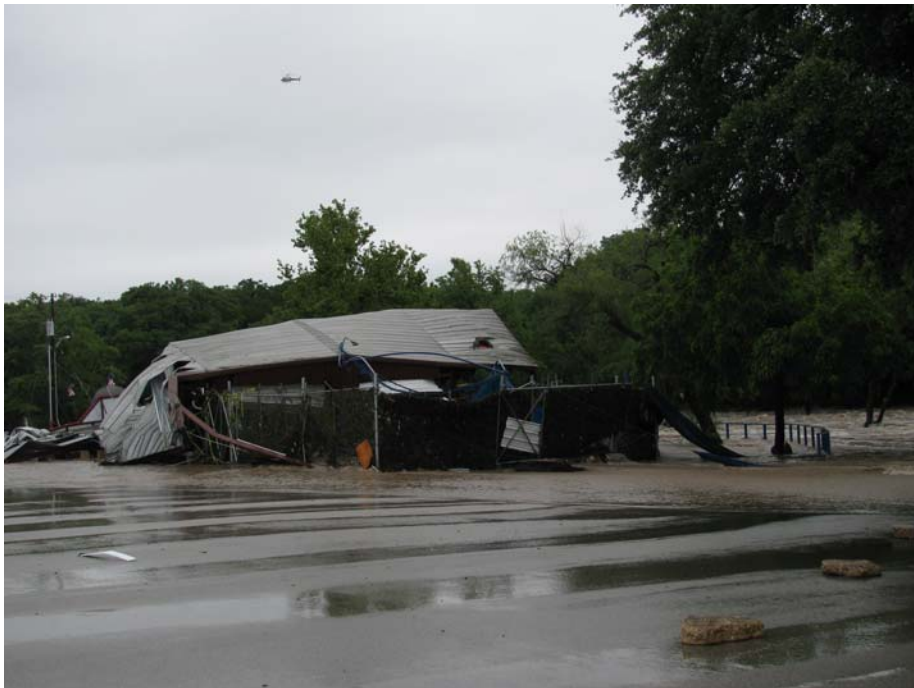
Photo 2, Building damage near the Gruene River bridge

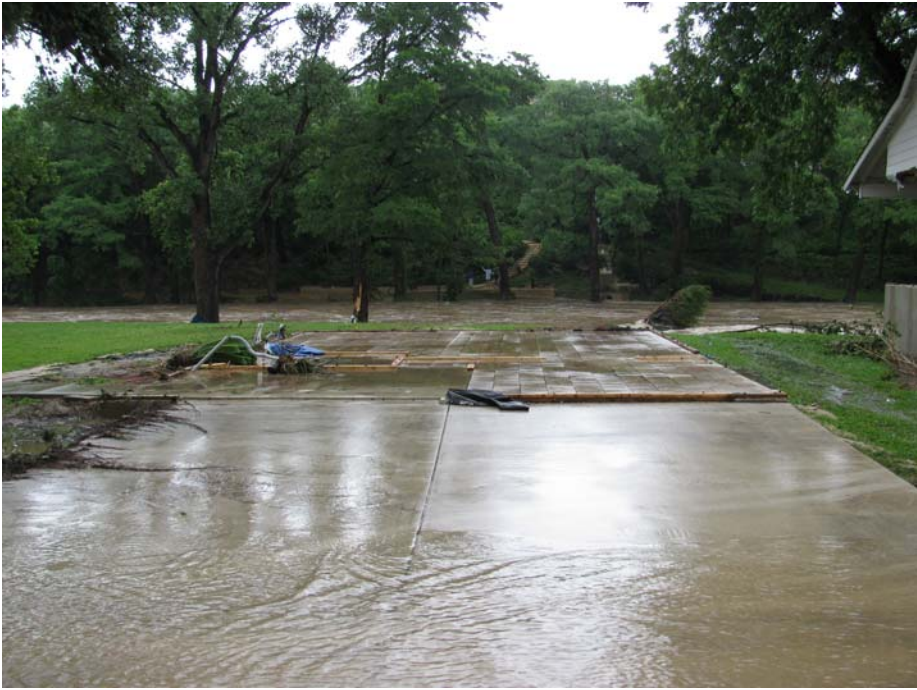
Photo 4, Home swept off it's foundation in Gruene

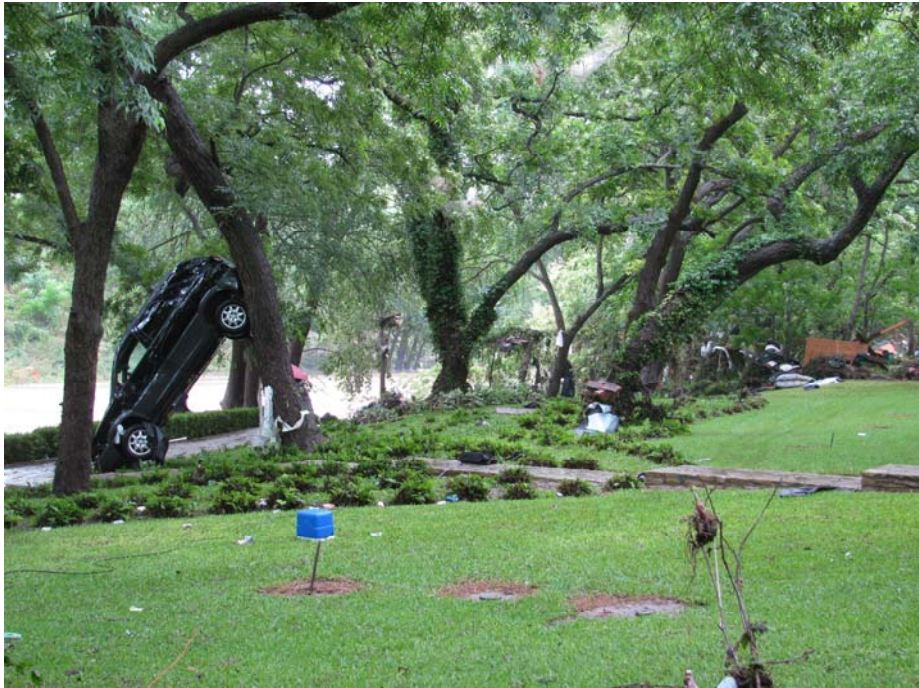
Photo 6, Damage along the banks of the river

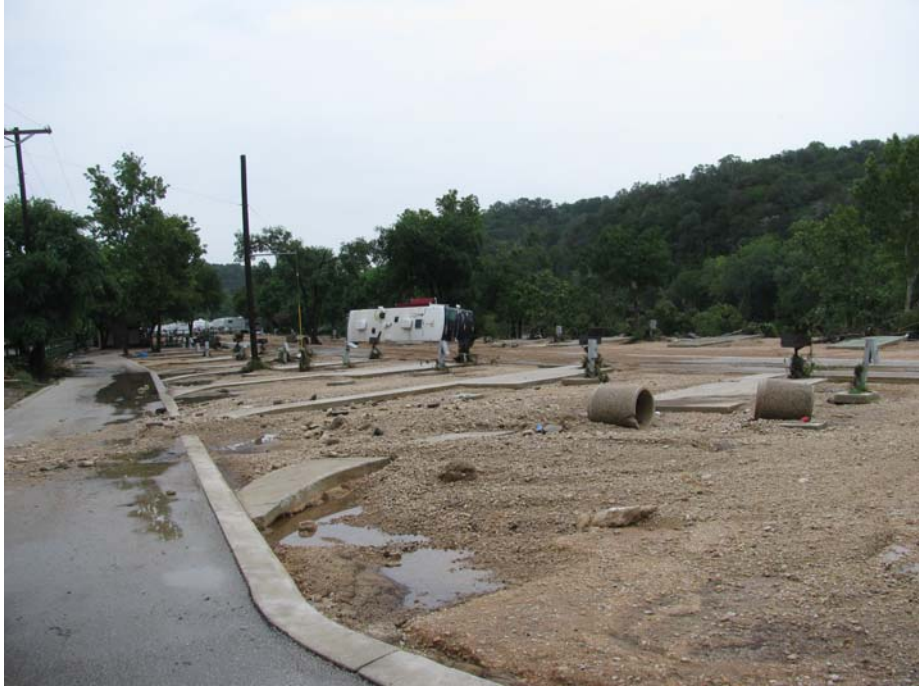
Photo 7, Remnants of a campground along River Road downstream from Crossing #1

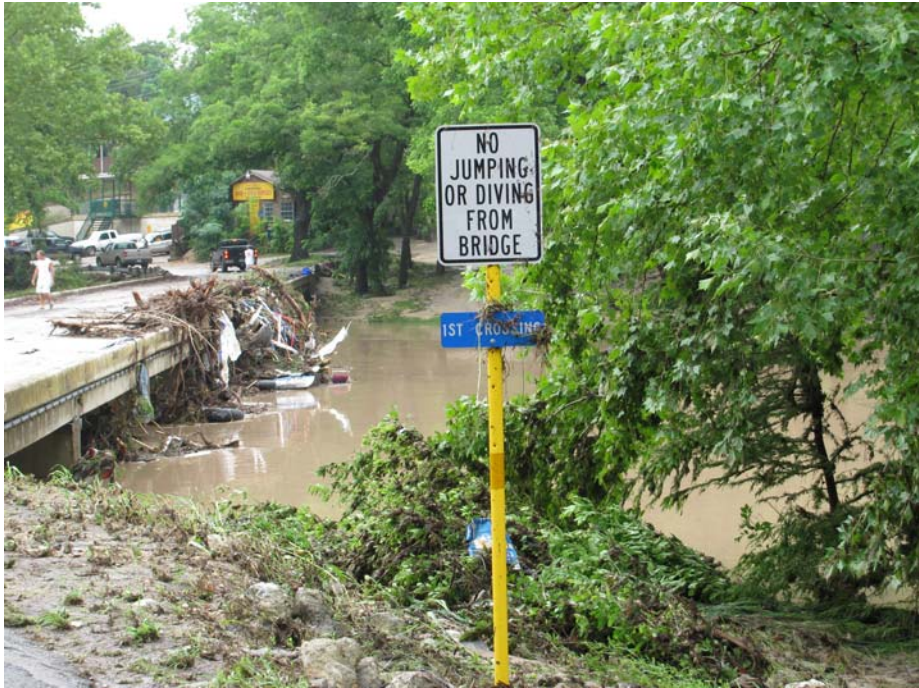
Photo 8, Bridge Crossing #1, River Road at the Guadalupe River

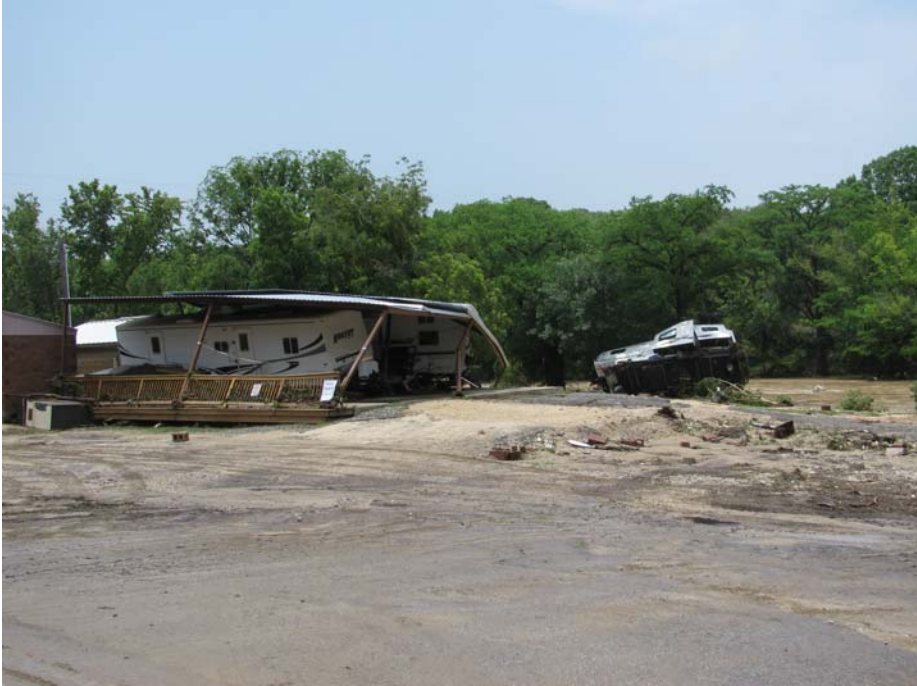
Photo 11, Camper trailers swept downstream from a campground

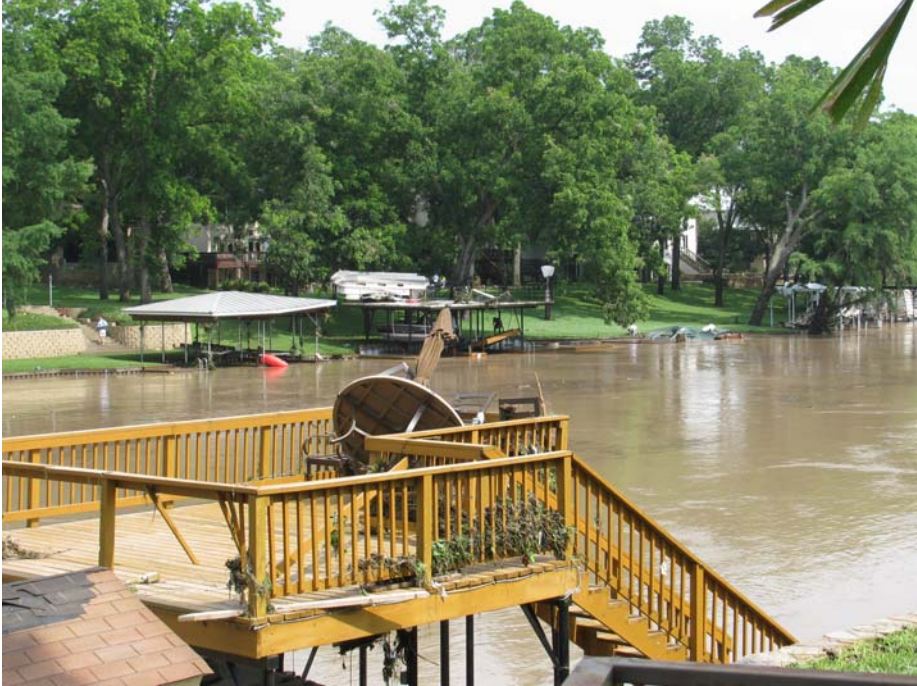
Photo 15, Debris on top of decks below Lake Dunlap

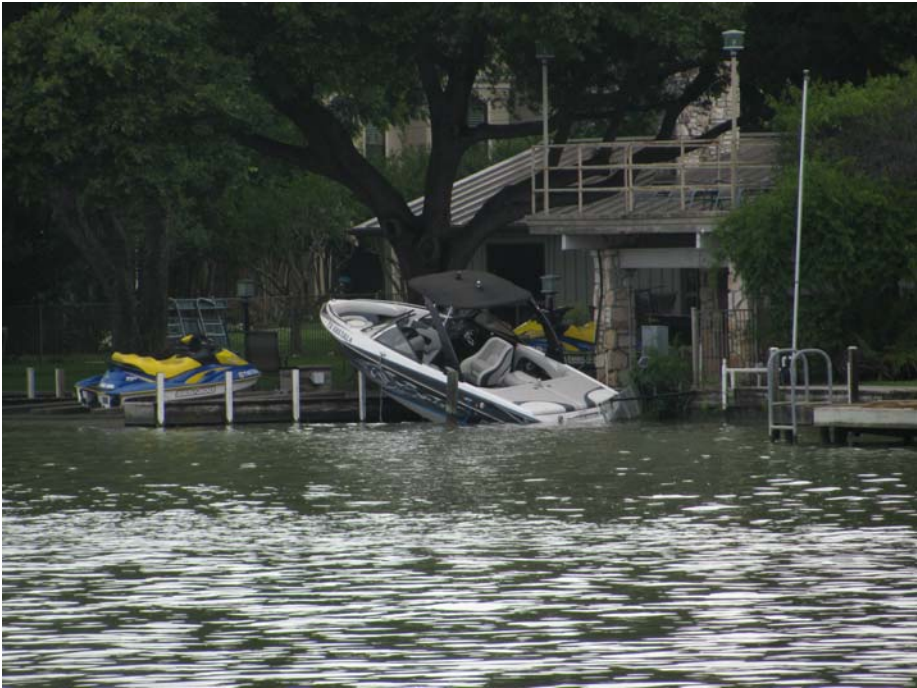
Photo 16, Boat showing the river rise on Treasure Island on Lake McQueeney
