Storm Survey of the Tornado Near Moulton, TX on September 7, 2010

PUBLIC INFORMATION STATEMENT NATIONAL WEATHER SERVICE AUSTIN/SAN ANTONIO TX 448 PM CDT WED SEP 8 2010

...TORNADO CONFIRMED NEAR MOULTON IN LAVACA COUNTY ...

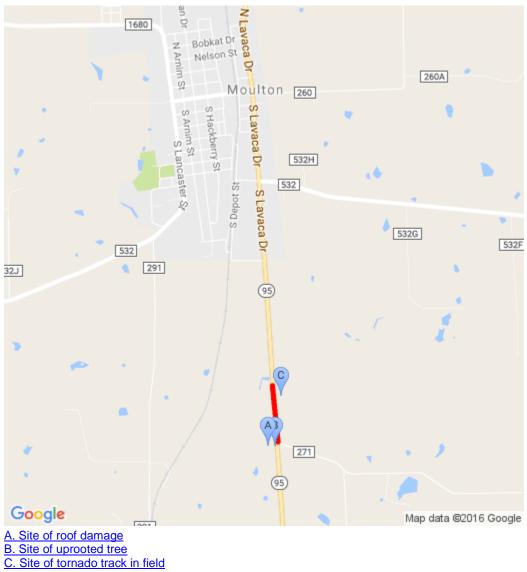
Track...

THE TORNADO FORMED ON 09/07/2010 AROUND 337 PM ALONG HIGHWAY 95 APPROXIMATELY 1 MILE SOUTH OF MOULTON IN LAVACA COUNTY. THIS IS VERY NEAR THE INTERSECTION OF HIGHWAY 95 AND COUNTY ROAD 271. A PORTION OF A ROOF WAS BLOWN OFF AN ABANDONED BUILDING WITH A TREE ALSO BEING UPROOTED ON THE PROPERTY. THE TORNADO MOVED NORTH ALONG THE EAST SIDE OF HIGHWAY 95 AND TRAVELED THROUGH A CORN FIELD WHERE THE TRACK WAS CLEARLY VISIBLE . THE TORNADO THEN LIFTED OR WEAKENED JUST SOUTH OF MOULTON AFTER TRAVELING 0.2 MILES. MAXIMUM WIND SPEEDS ARE BEING ESTIMATED AT 65 MPH WITH A MAXIMUM WIDTH OF 50 YARDS. THIS TORNADO IS BEING RATED AS AN EF0 ON THE ENHANCED FUJITA SCALE. NO INJURIES OR DEATHS WERE REPORTED WITH THIS TORNADO.

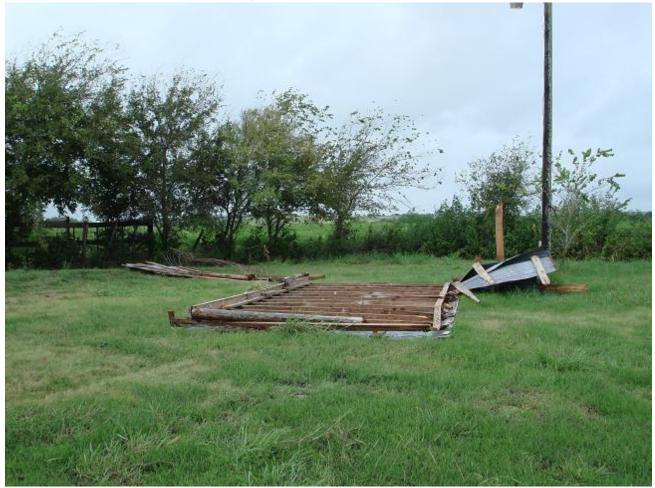
A. Site of Roof Damage

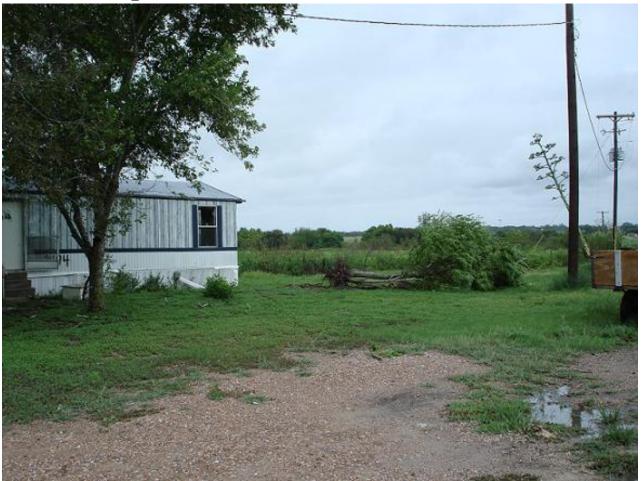
B. Site of Uprooted Tree

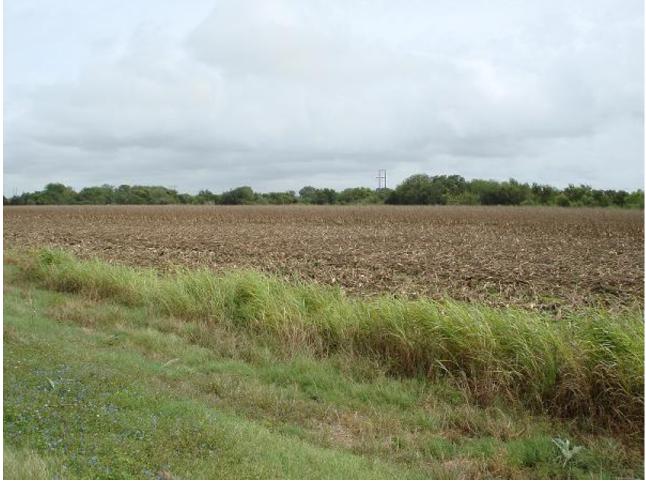
C. Site of Tornado Track in Field
