Hydrologic Summary: Active Spring Runoff and Bank Erosion Issues

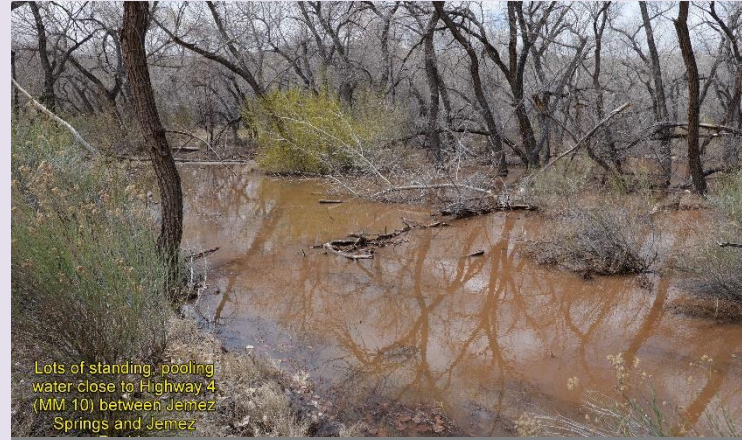
Lots of standing, pooling water close to Highway 4 (NM 10) between Jemez Springs and Jemez

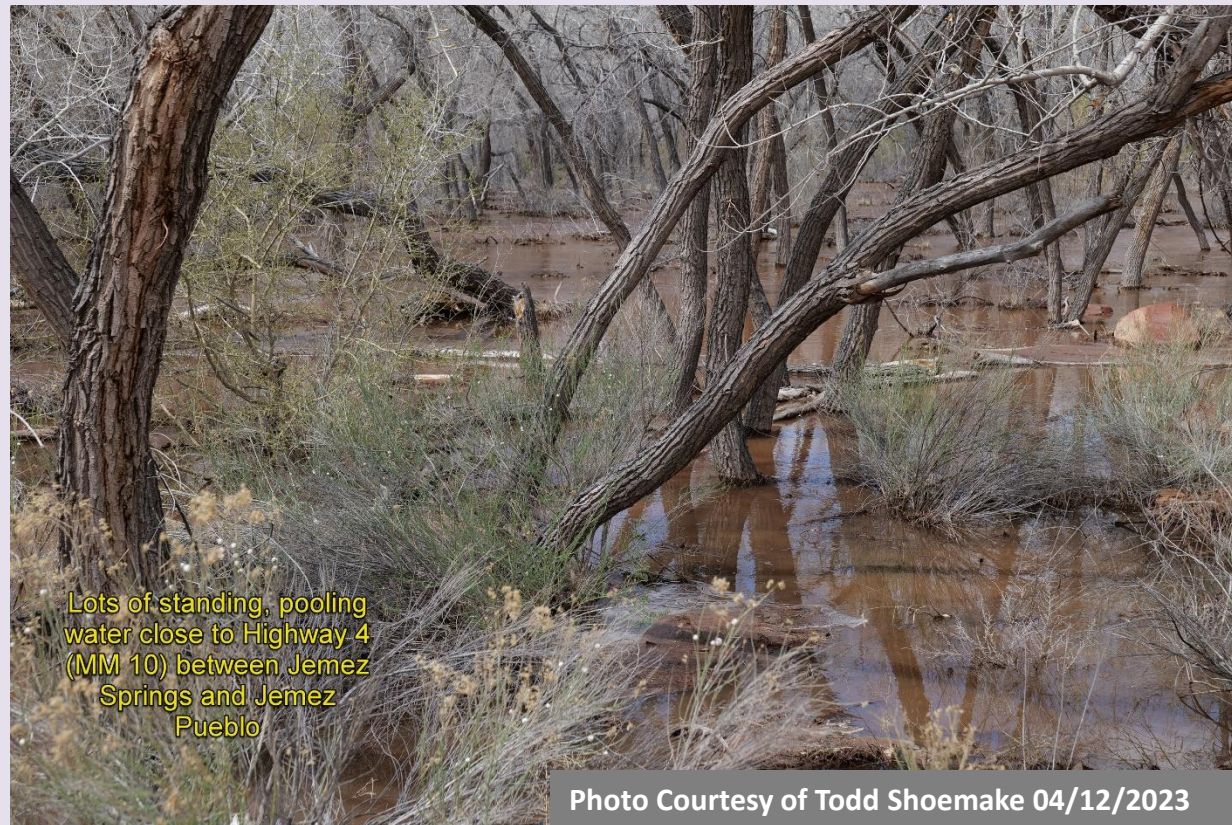
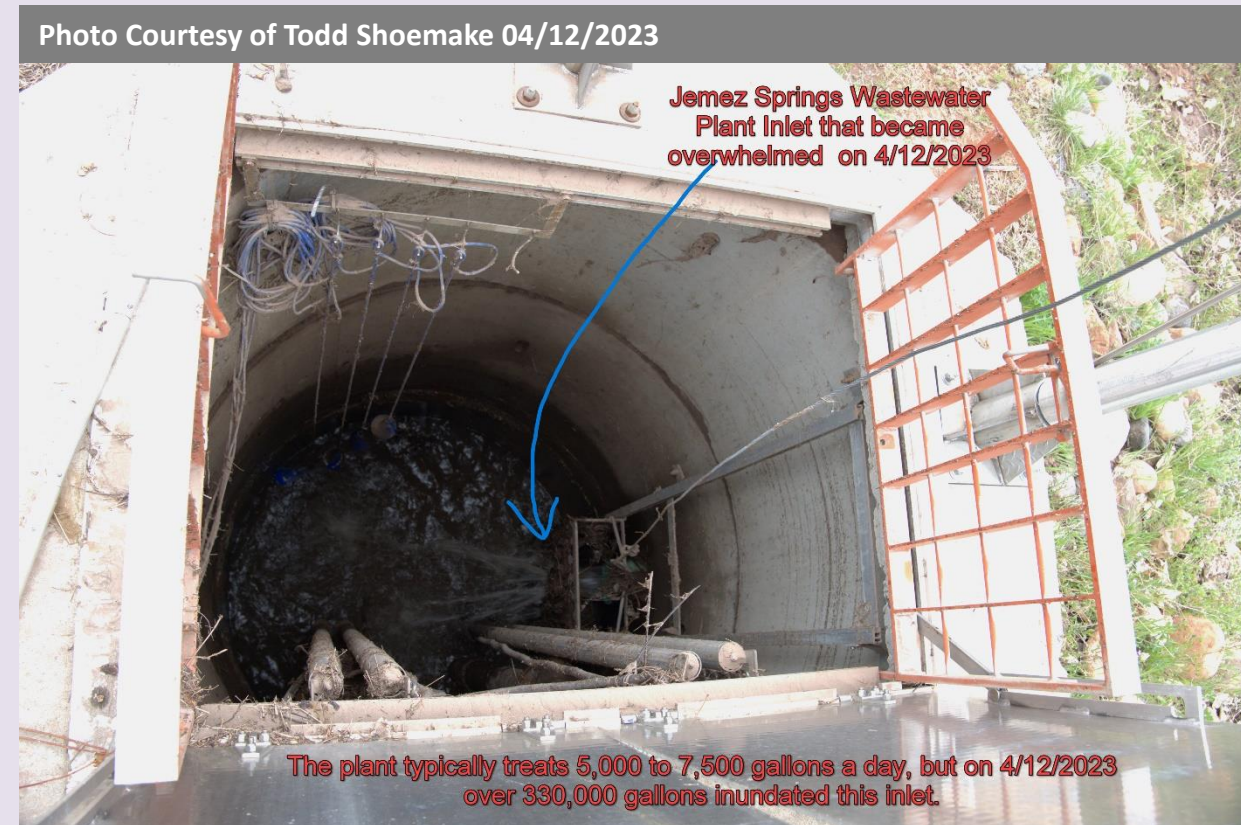
Impacts up and down the Jemez River Valley were numerous.

- High up in the valley a small bridge was badly damaged and convenient access to several homes.
- At the low end of the valley, a small levee failed and flooded out farmland in San Ysidro.
- The bosque was completely flooded and all campground, picnic grounds and fishing spots were closed for several weeks.
- Water flooded out Highway 4 at several spots. Thankfully that was fairly short lived and access to the river valley was restored within a day.
- The most expensive impact occurred in the town of Jemez Springs, when rushing waters found their way into the wastewater treatment system and completely overwhelmed the inlet. This destroyed the wastewater treatment plant and flushed sewage down the river. A county disaster was declared largely because of the loss of this treatment plant. With assistance from other plants, the WWTP in Jemez Springs came back online within a month.

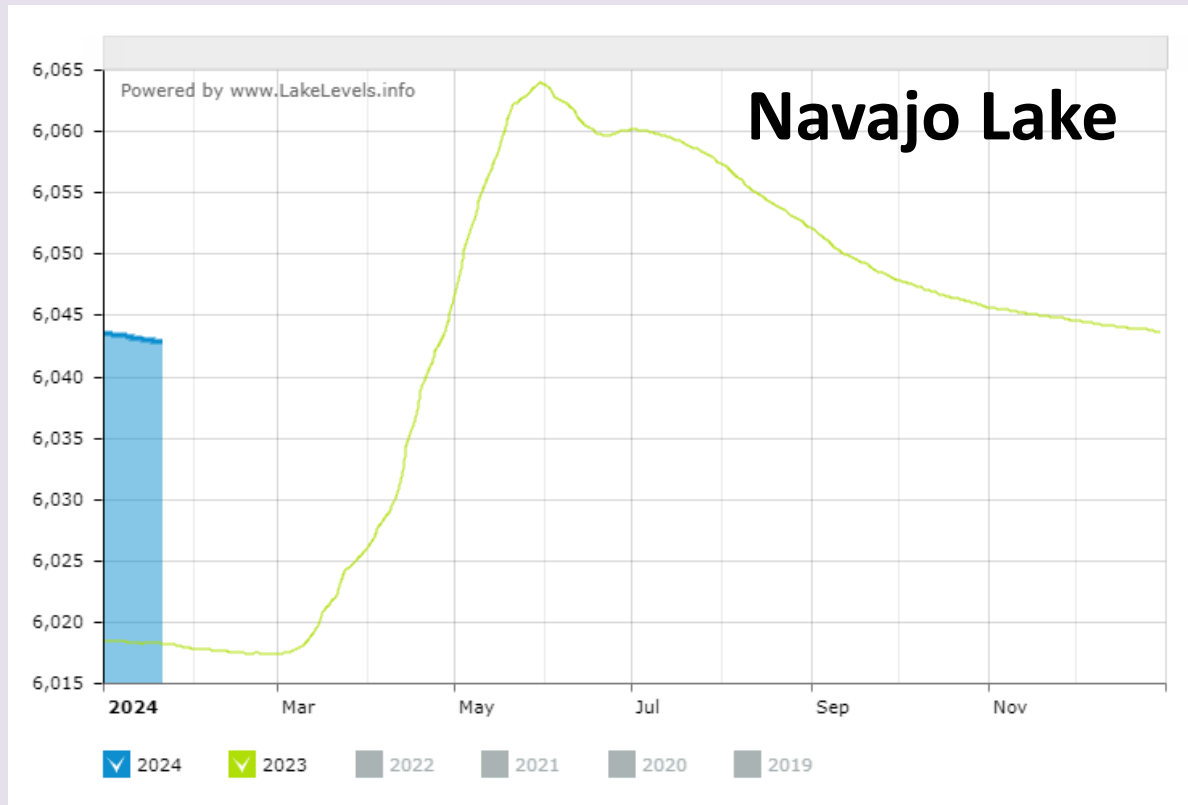
Two of the most important reservoirs that can be directly impacted by snowmelt runoff are Navajo, which controls flows in the San Juan River and Abiquiu, which controls flows along the Rio Chama, a major tributary of the Rio Grande. Both of these reservoirs saw remarkable rises in their lake levels:

- In Navajo, we saw lake levels rise ~46 feet.
- In Abiquiu we saw lake levels rise ~33 feet.

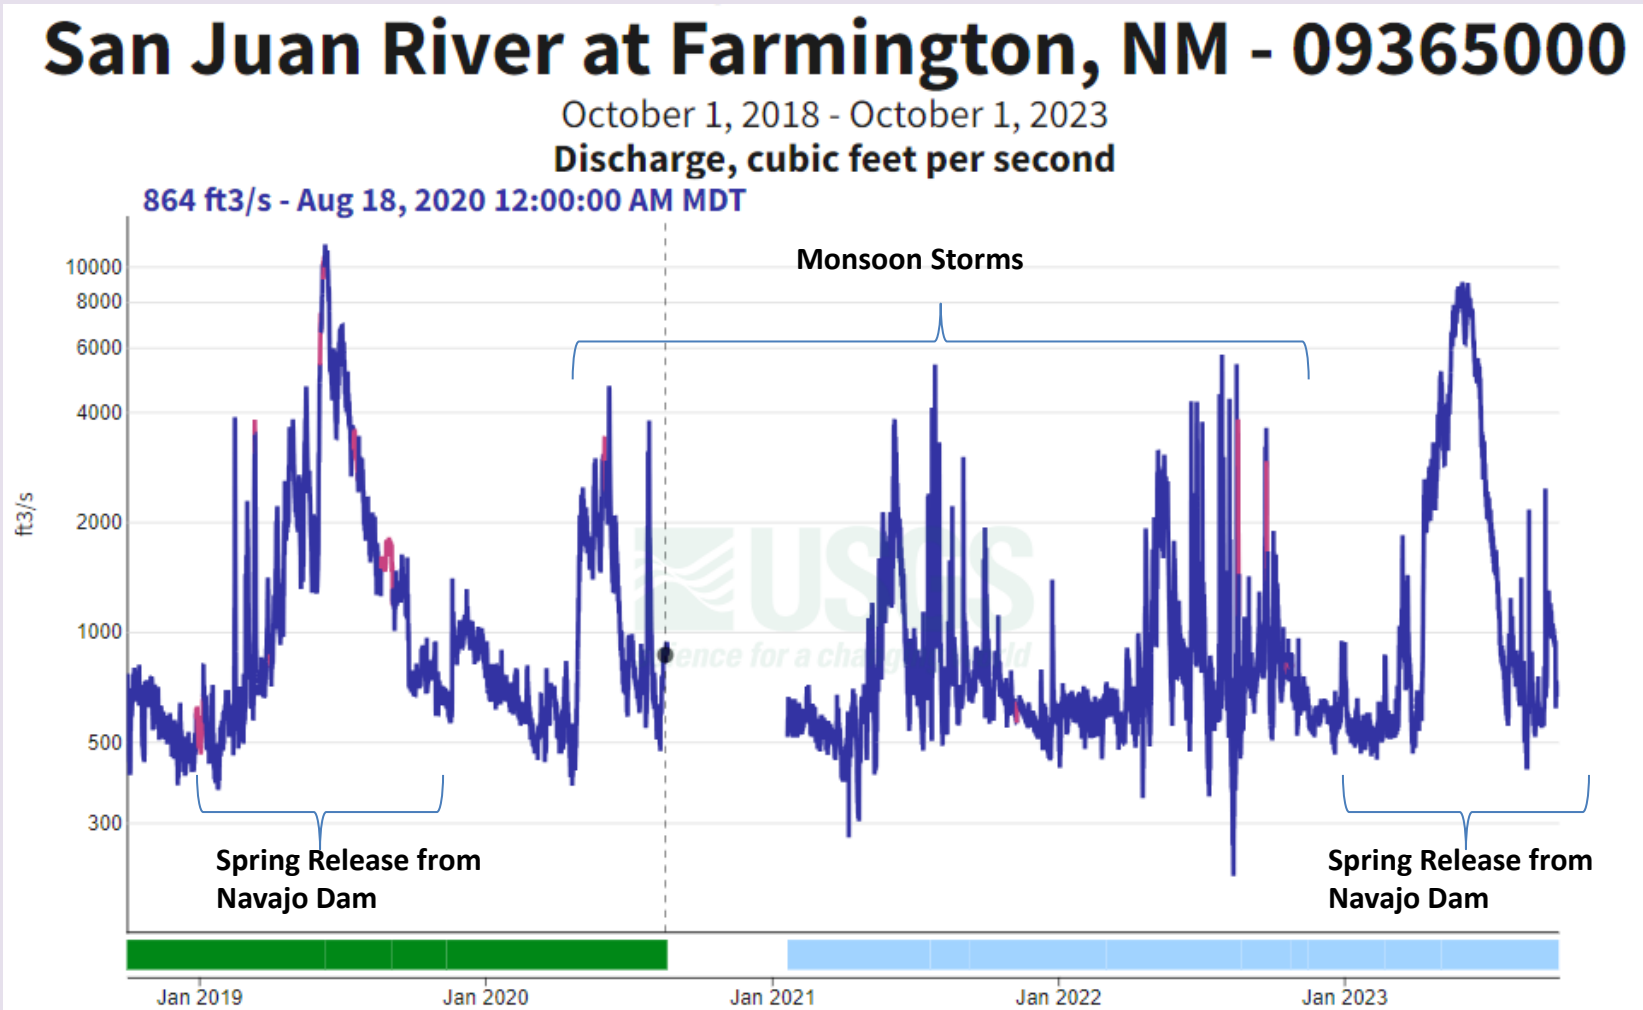
The plot above highlights the differences between prolonged flow and rapid bursts of monsoon runoff in the San Juan River. The spring release from Navajo was the first one that occurred since 2019, due in large part to lackluster winter snowpack. However, Monsoon storms carried on in the summers. Just as we saw with the Jemez River, we saw impacts at levels we were not expecting them, including significant bank erosion.

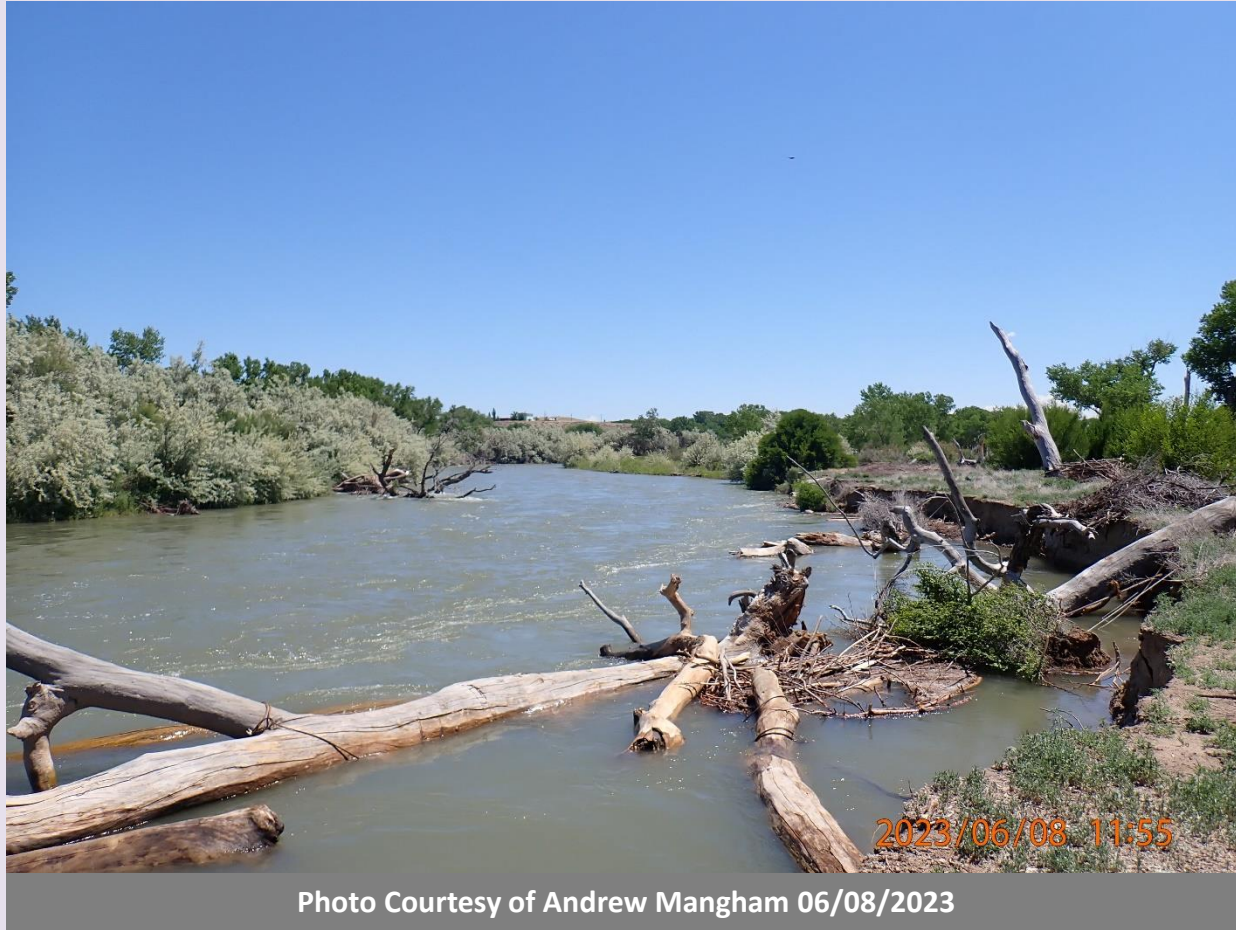
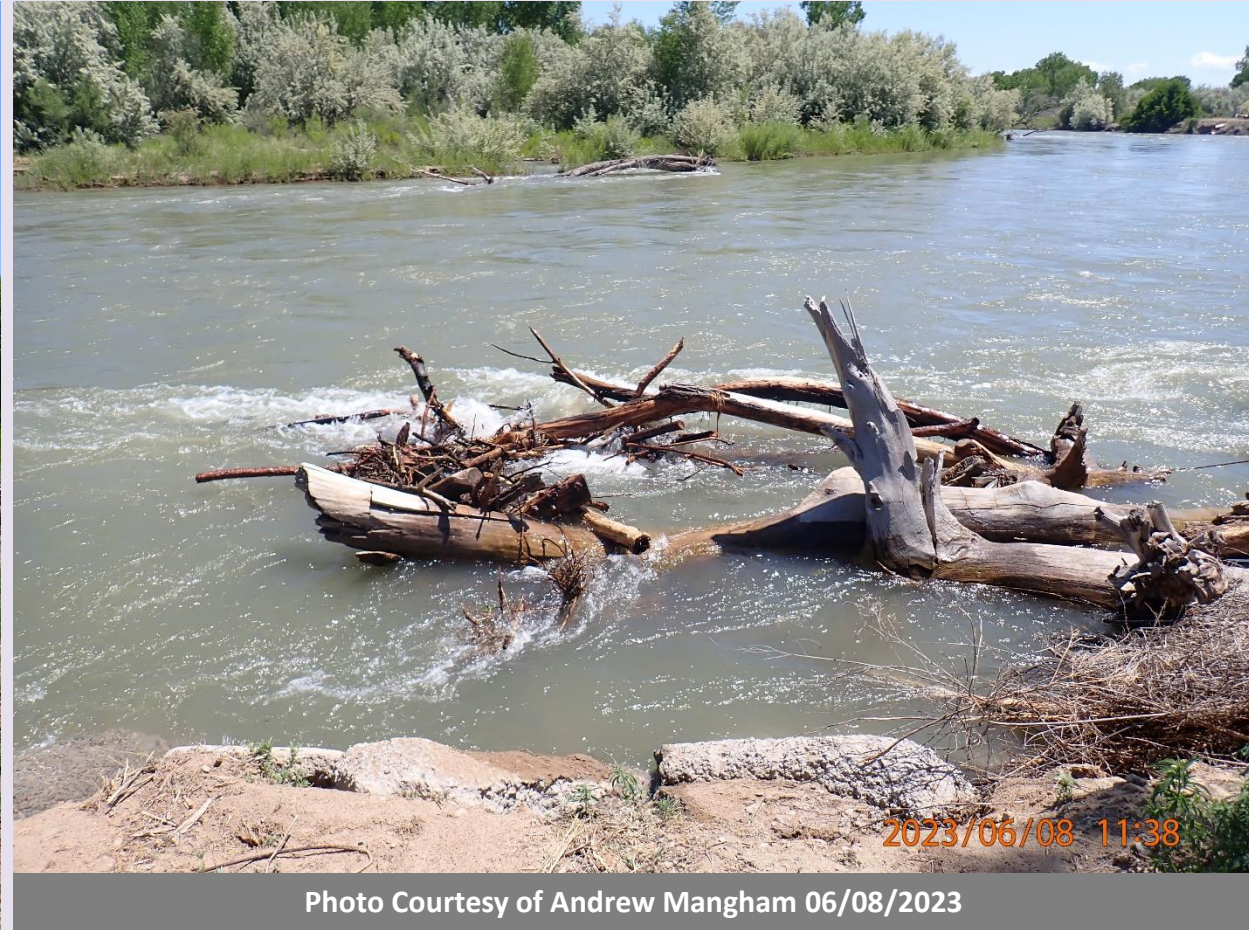
A riverfront property in Bloomfield saw sever erosion of its banks with logs and bushes tumbling into the river as the banks gave way. At this location the homeowner was attempting to prevent further erosion by securing those logs with cables so they would stay in place and act as armor against he flows.

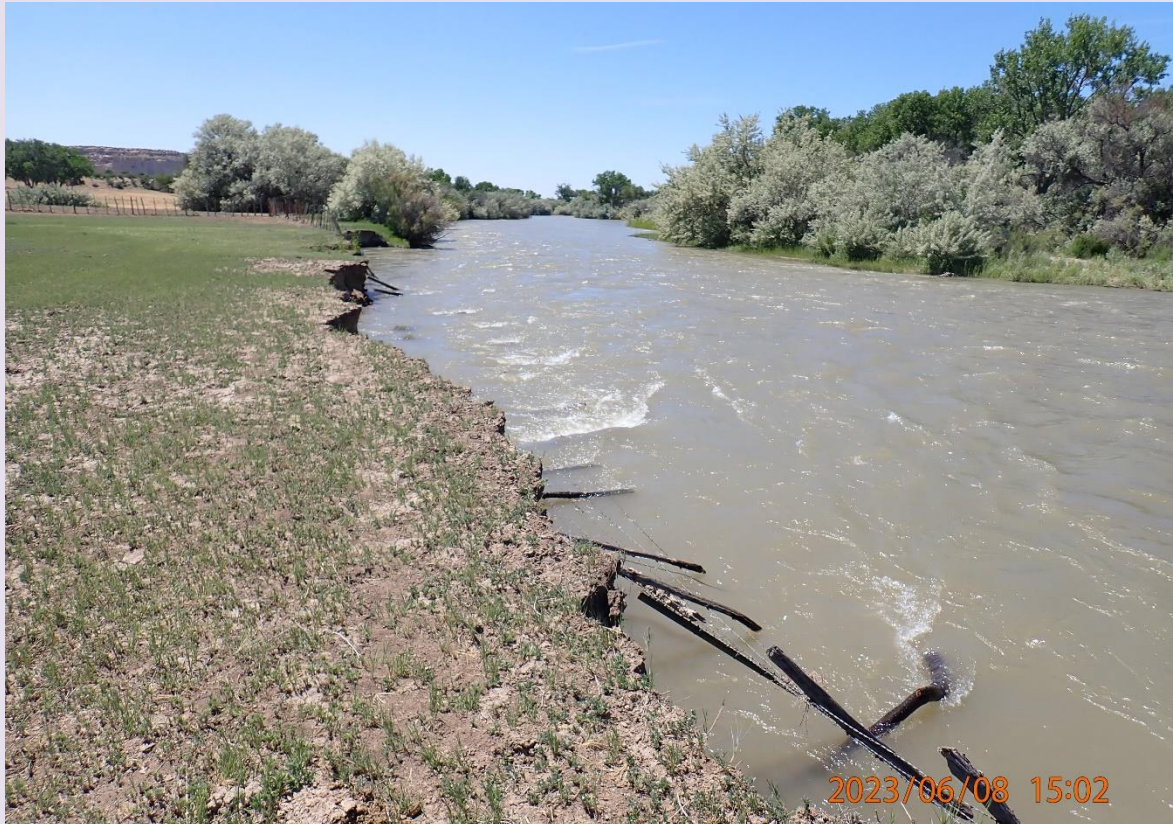
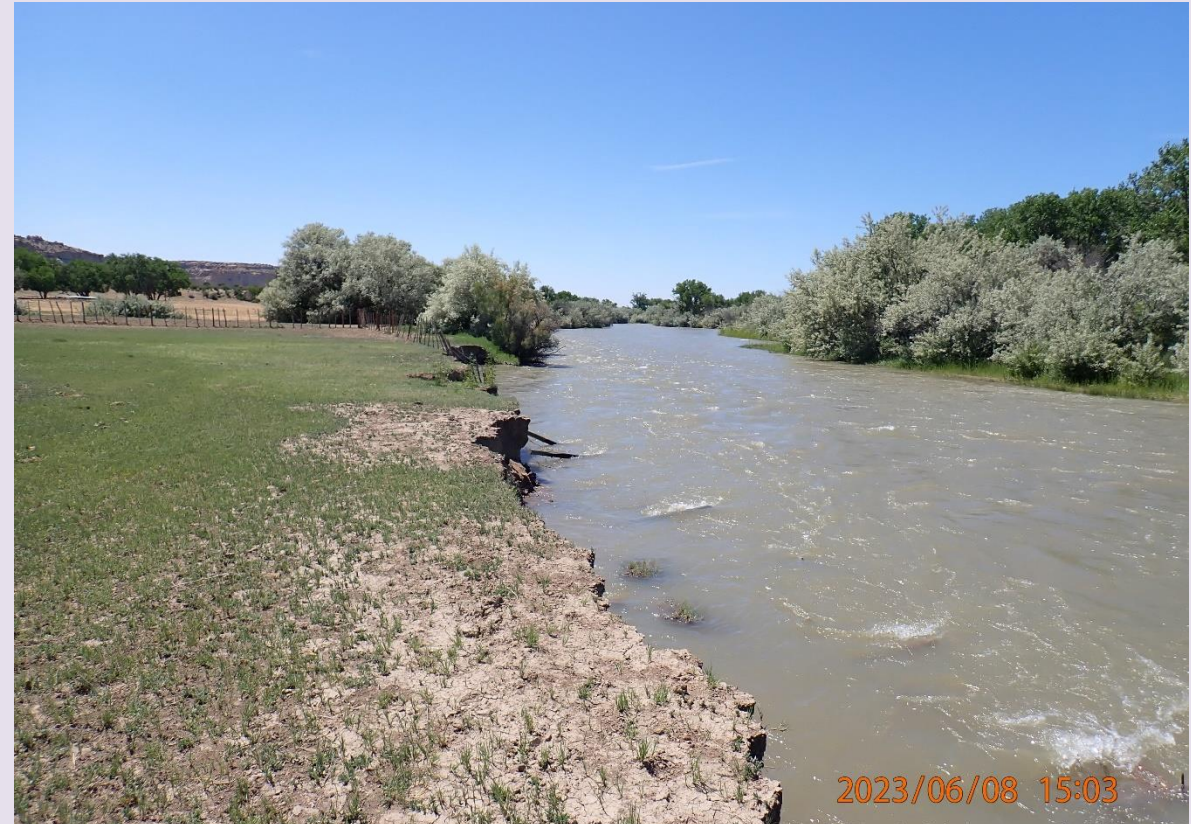
A rancher in Farmington saw a 100 foot stretch of riverbank on the northern edge of one pasture lose an estimated 10 feet of depth, causing fences to collapse into the river.

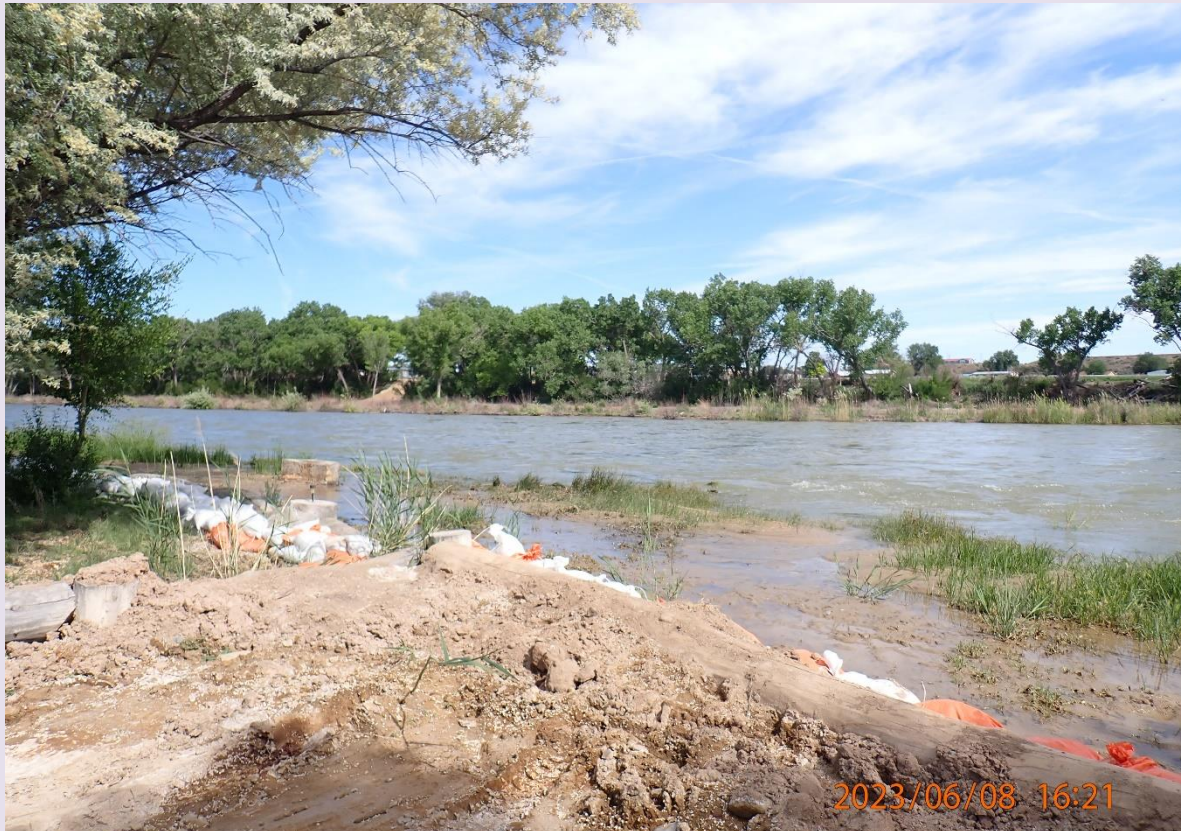
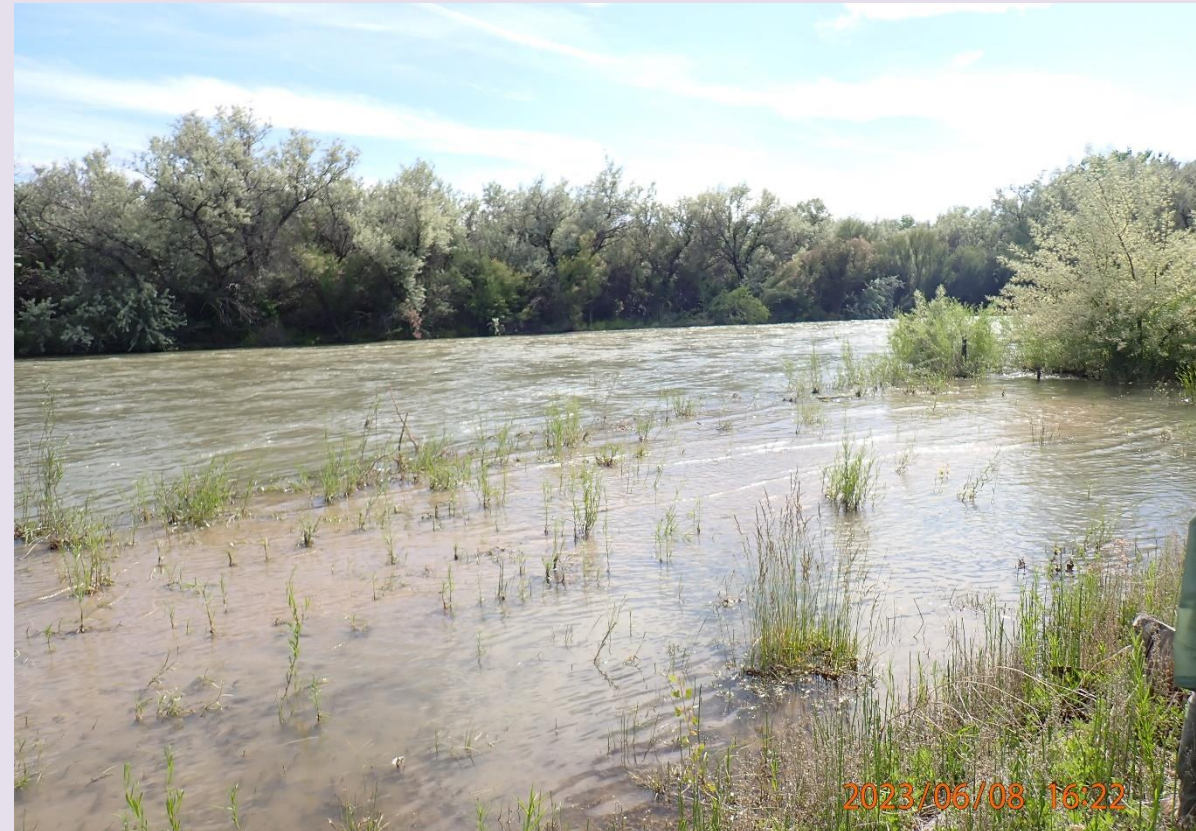
One family in Farmington with riverfront property had their entire property flooded out. They had to sandbag the banks and the entrances to keep the water out of their residence. Nonetheless, their septic tank was damaged and a propane tank was washed a short way downstream. Several other properties along this stretch of the San Juan River met similar fates, with varying degrees of damage.

These are all pictures of flooding associated with the release from Navajo Lake. Similar impacts occurred on the Rio Chama, downstream of the point where water released from Abiquiu dam was joined by uncontrolled and very high flow from the Rio Ojo Caliente. As a result Abiquiu had to drop the flows it was releasing and keep that release going for several weeks longer than they projected.

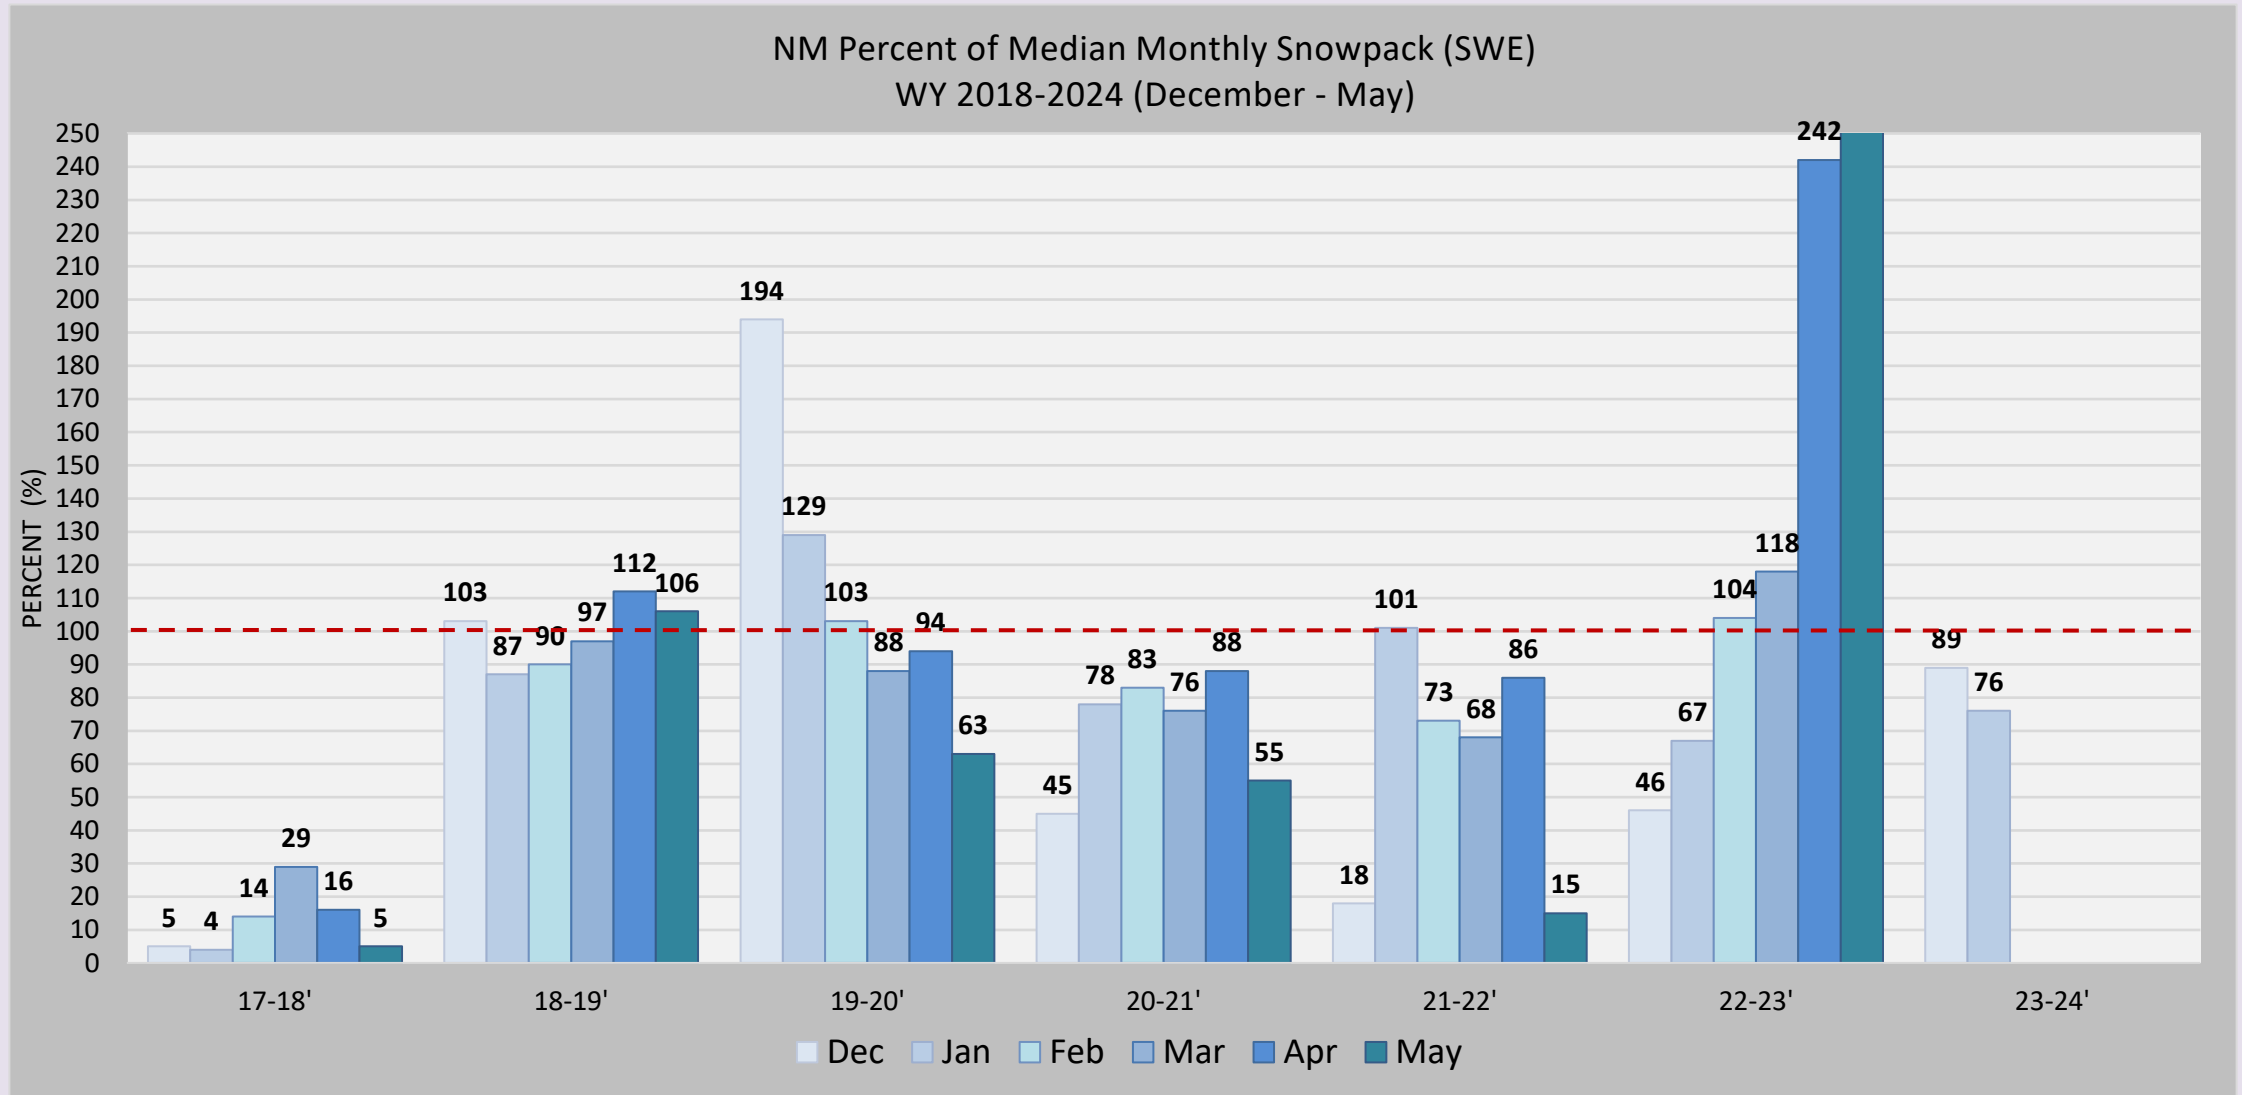
The chart above is the same as the previous slide but for 2018 to 2024. The 2017-2018 season was practically snow-free. The following 2018-2019 season made a big comeback with close to median snowpack through the entire season. 2019-2020 started out great then trailed off by late spring. 2020-2021 was fair followed by more struggles in 2021-2022. The 2022-2023 season ramped up January with very good SWE by the spring. 2023-2024 is off to a fair start with more active weather expected in February.
