The 100th Anniversary of the 1914 Record Flood at Schenectady

Steve DiRienzo and Britt Westergard
 NOAA/National Weather Service
 Weather Forecast Office
 Albany, NY
 Stephen.Dirienzo@noaa.gov or Britt.Westergard@noaa.gov

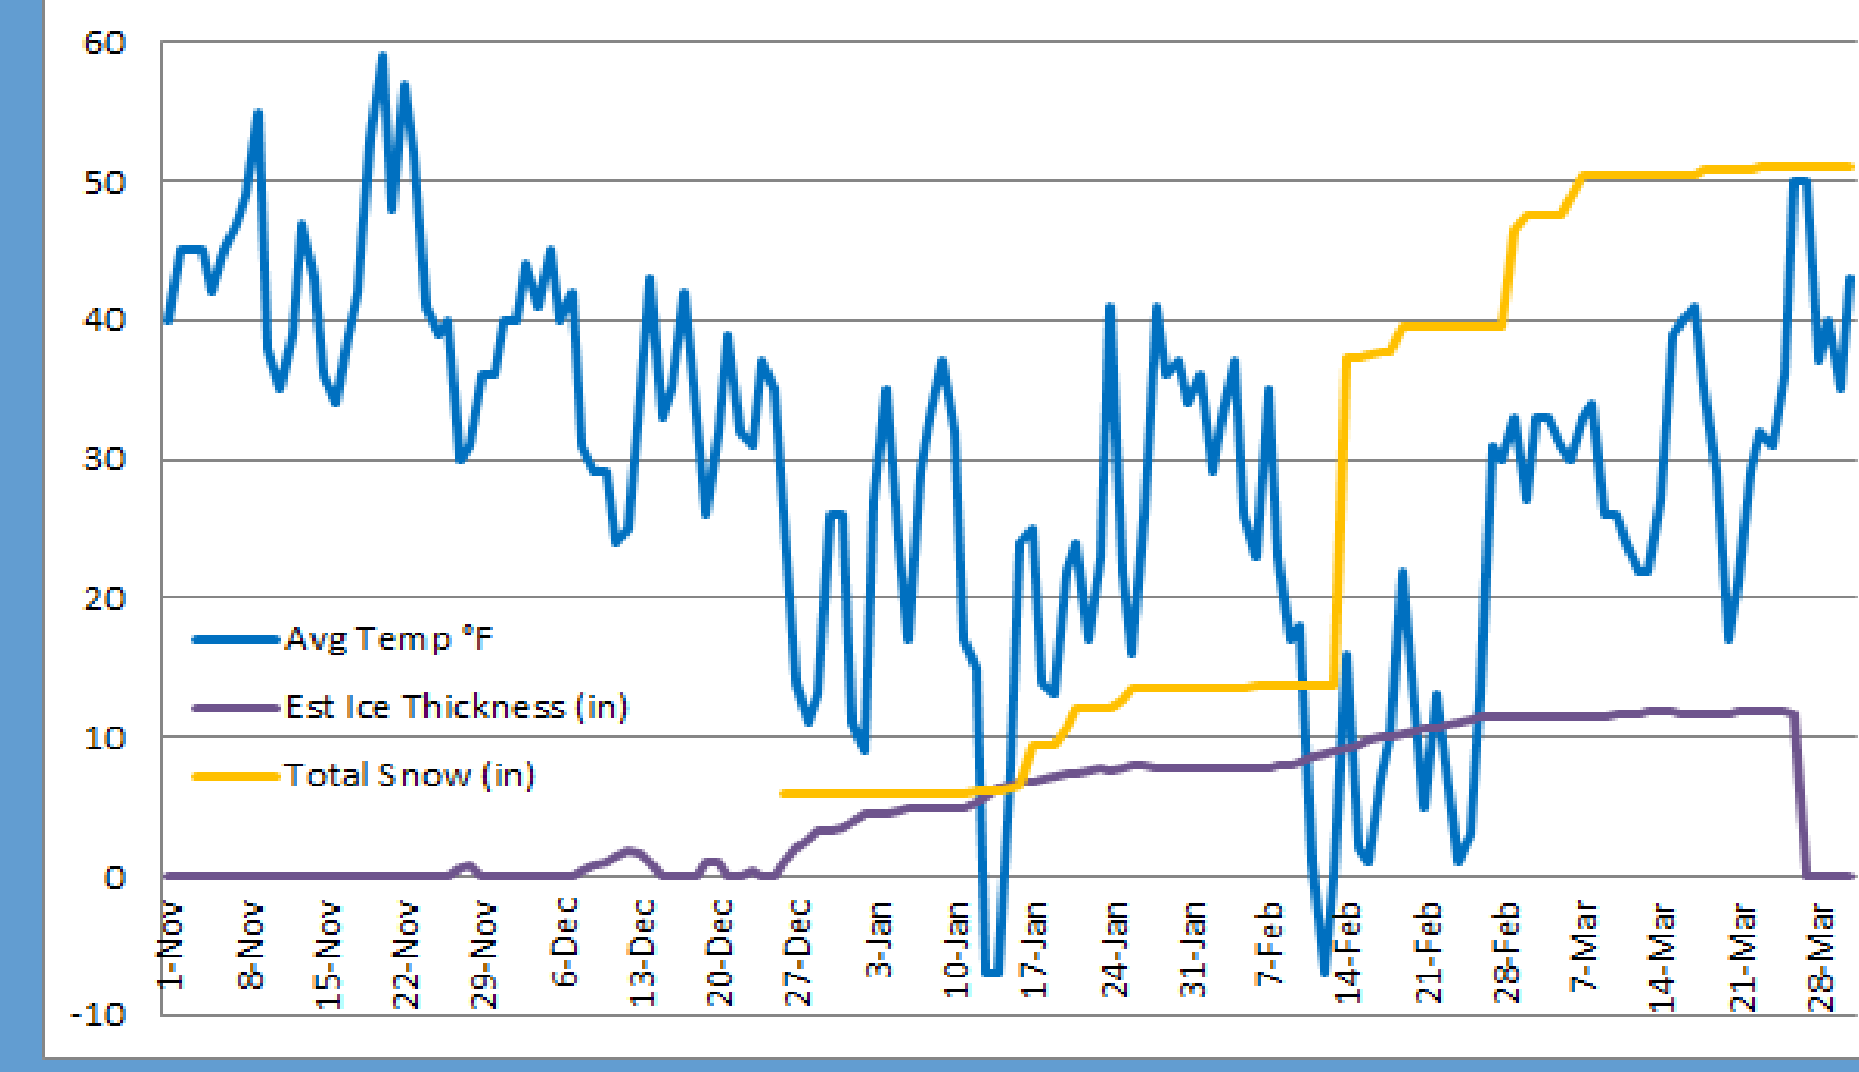
Daily Average Temperature, Estimated Ice Thickness and Accumulated Snow 1913-1914

Simulated ice thicknesses are compared with photos from each event showing ice thickness, and with United States Geological Survey (USGS) records. The simulated ice thicknesses are fairly accurate based on the observational evidence. A complicating factor is snowfall during the ice accumulation period. According to observational evidence, greater snowfall during this period leads to thicker river ice.

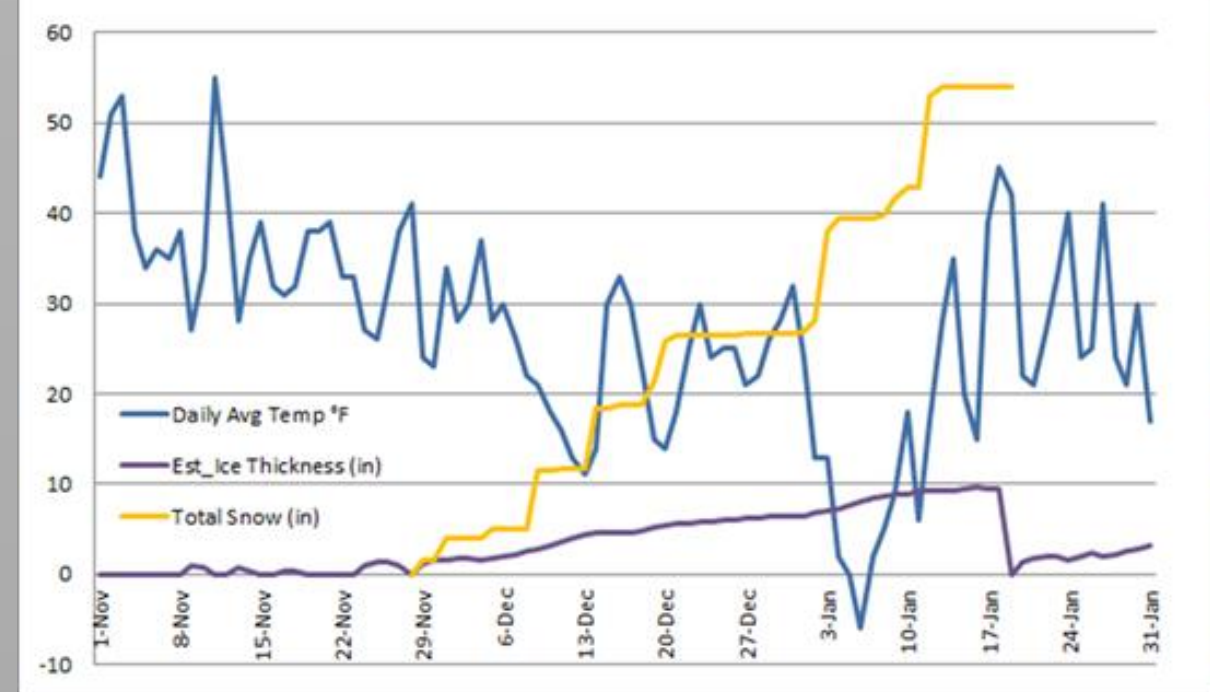
Daily Average Temperature, Estimated Ice Thickness and Accumulated Snow 1995-1996

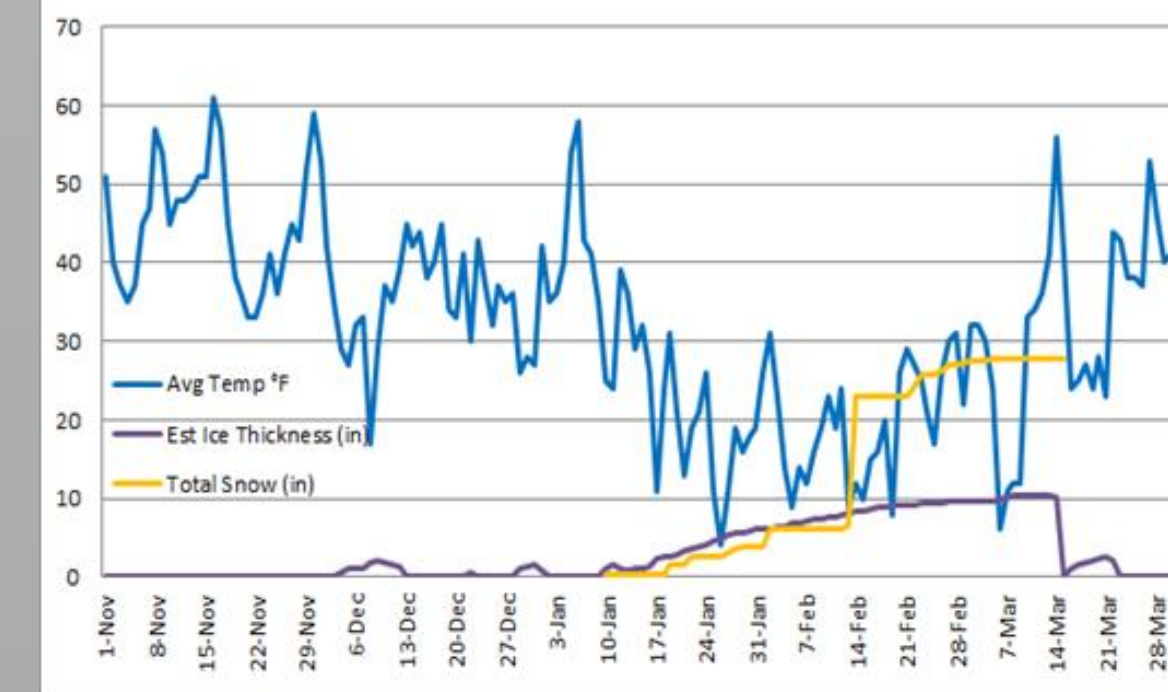
Daily Average Temperature, Estimated Ice Thickness and Accumulated Snow 2006-2007

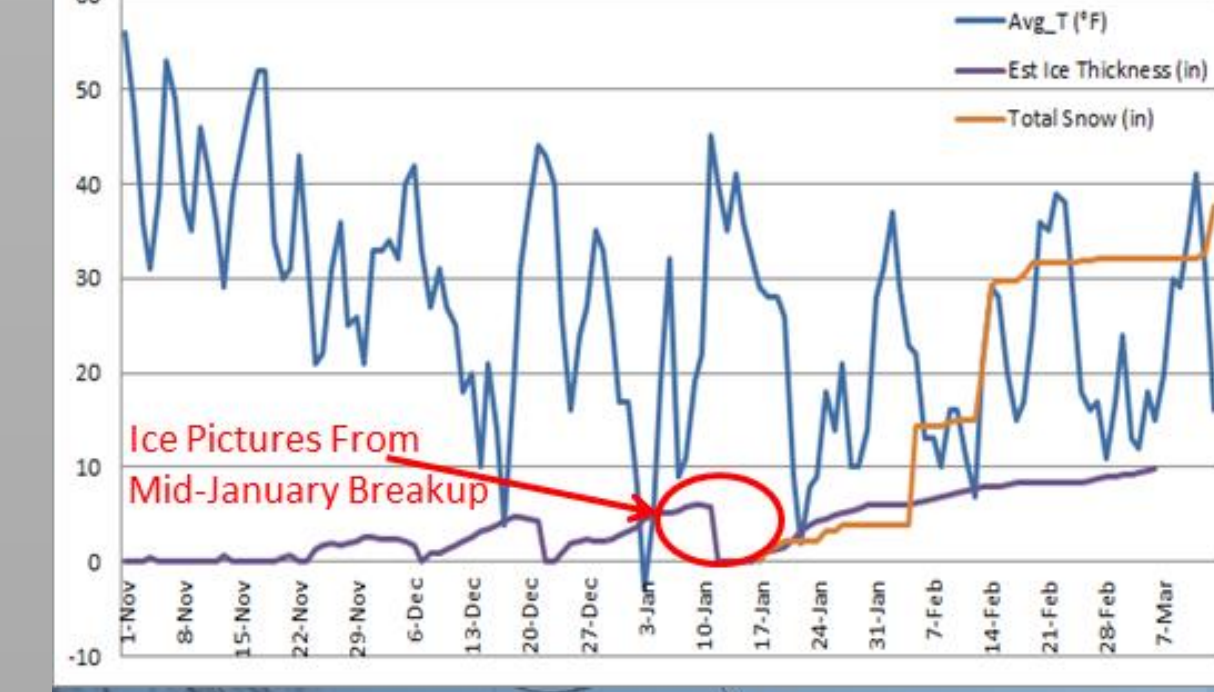
Daily Average Temperature, Estimated Ice Thickness and Accumulated Snow 2013-2014 (Albany, NY)
