The second notable event occurred later in the month, during the overnight hours from the 29th into the 30th. A nearly stationary band of showers and thunderstorms, associated with a departing upper low, light flow, and ample moisture, brought several inches to portions of the Northeast Kingdom over approximately 5 hours. High rainfall rates and the nearly stationary nature of these storms lead to extreme rainfall totals of 3 to 7 inches, with 7.30 inches in East Brighton, and 8.41 inches in St Johnsbury (CoCoRaHs). (Fig 7) The official Cooperative Observer in St Johnsbury reported a 24-hour total of 8.08 inches, the highest 24-hour total ever recorded at that site. Records there go back to 1894. The result of this extreme rainfall was catastrophic flash flooding, particularly in Lyndon, Morgan, and St. Johnsbury. Several rounds of increasingly dire Flash Flood Warnings were issued, ultimately ending in a Flash Flood Emergency. Although many roads, bridges, and buildings were damaged or destroyed, there were no fatalities. (Fig 8)

Figure 1: July 2024 precipitation across the NWS Burlington, HSA.

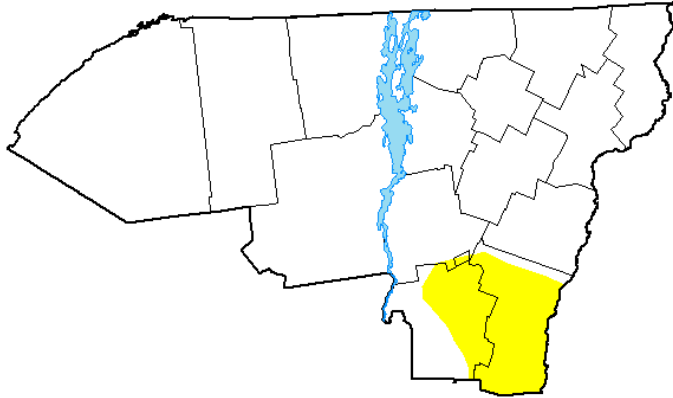
Figure 3: US Drought Monitor Map for week of July 30, 2024 showing abnormal dryness, or D0 conditions persisting across southern and eastern Vermont counties of the NWS Burlington HSA.

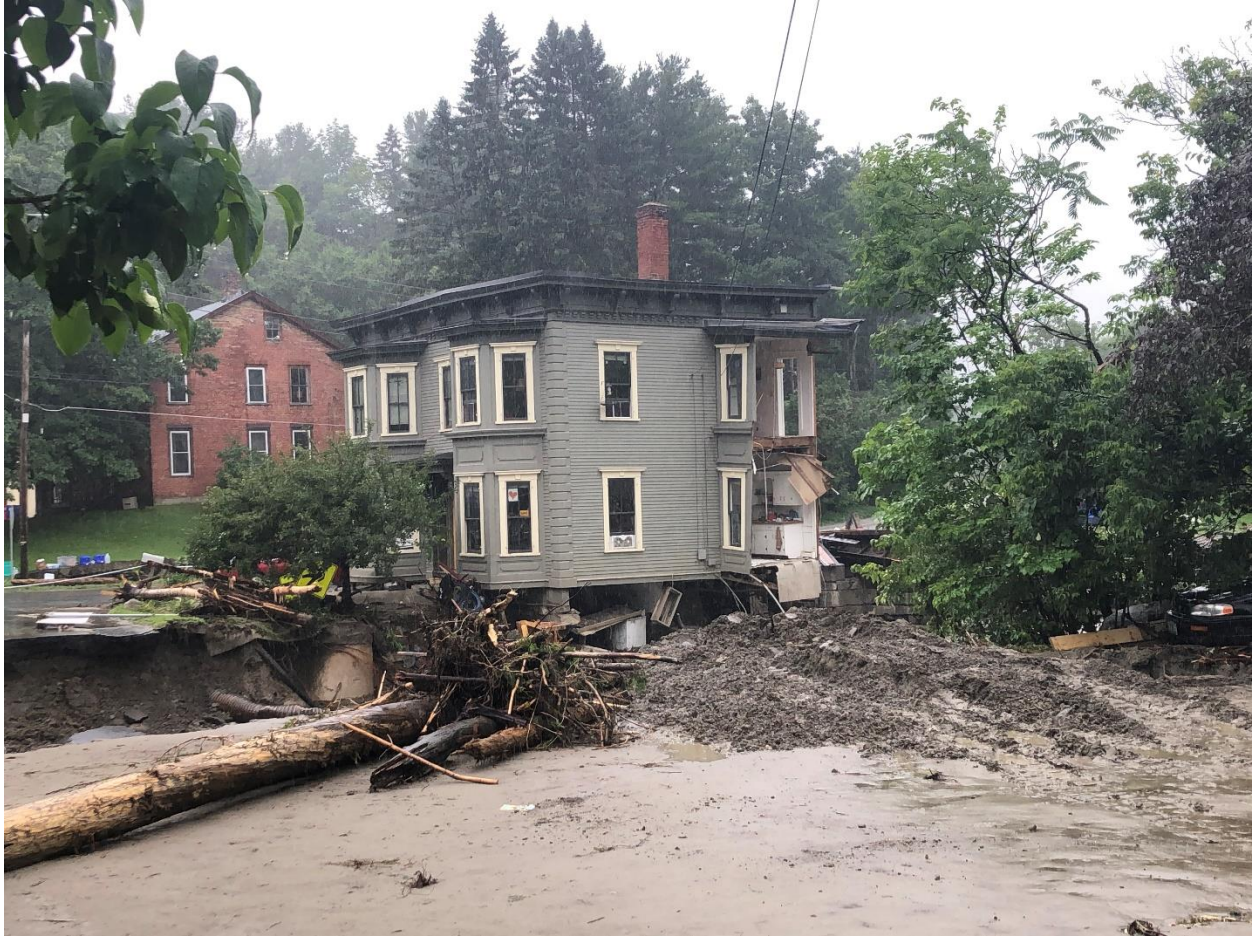
Figure 5: Significant flash flooding late on July 10 led to catastrophic damage in the Plainfield, VT area, including this apartment building that was almost completely washed away by the Great Brook.

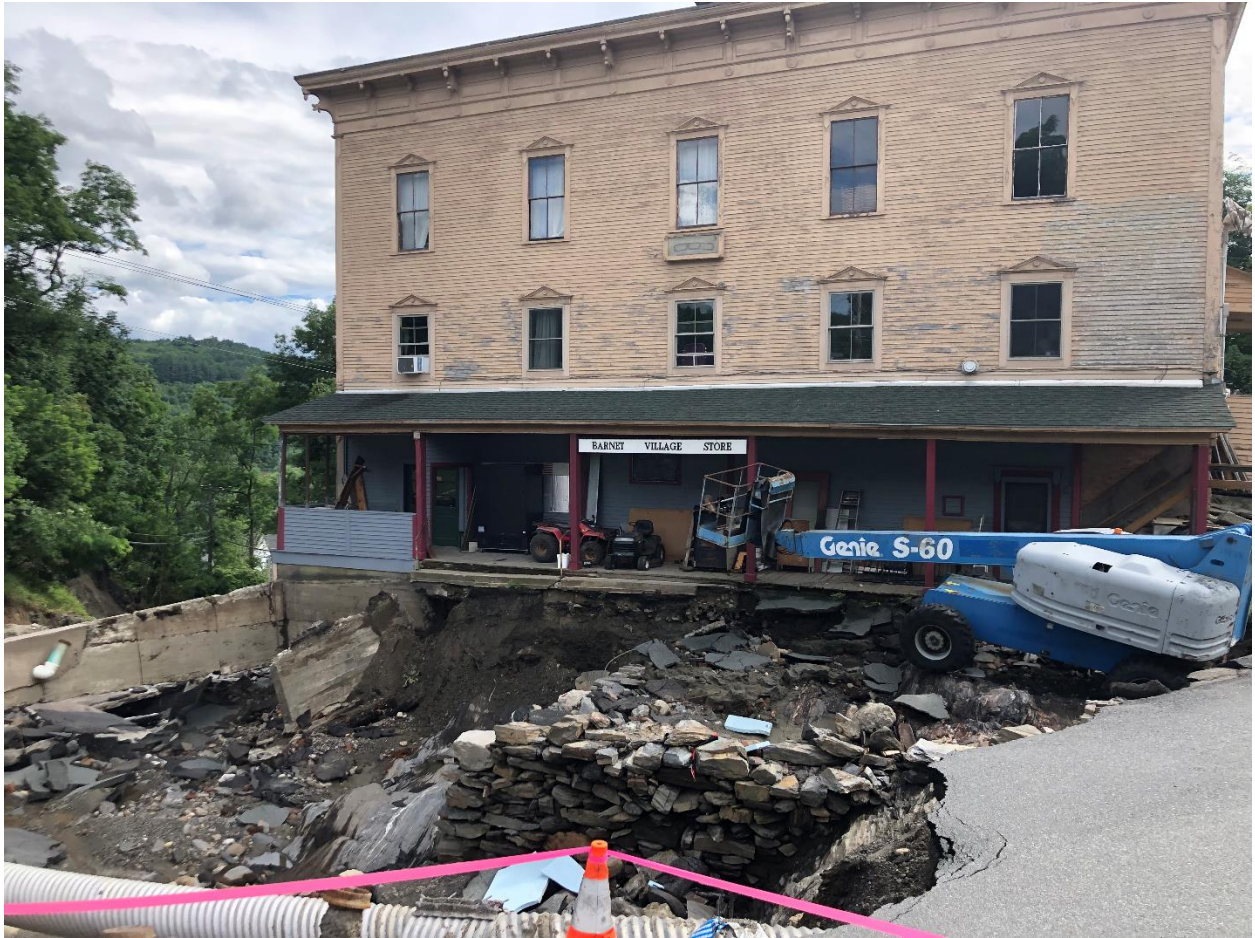
Figure 6: Catastrophic Flooding in Downtown Barnet.

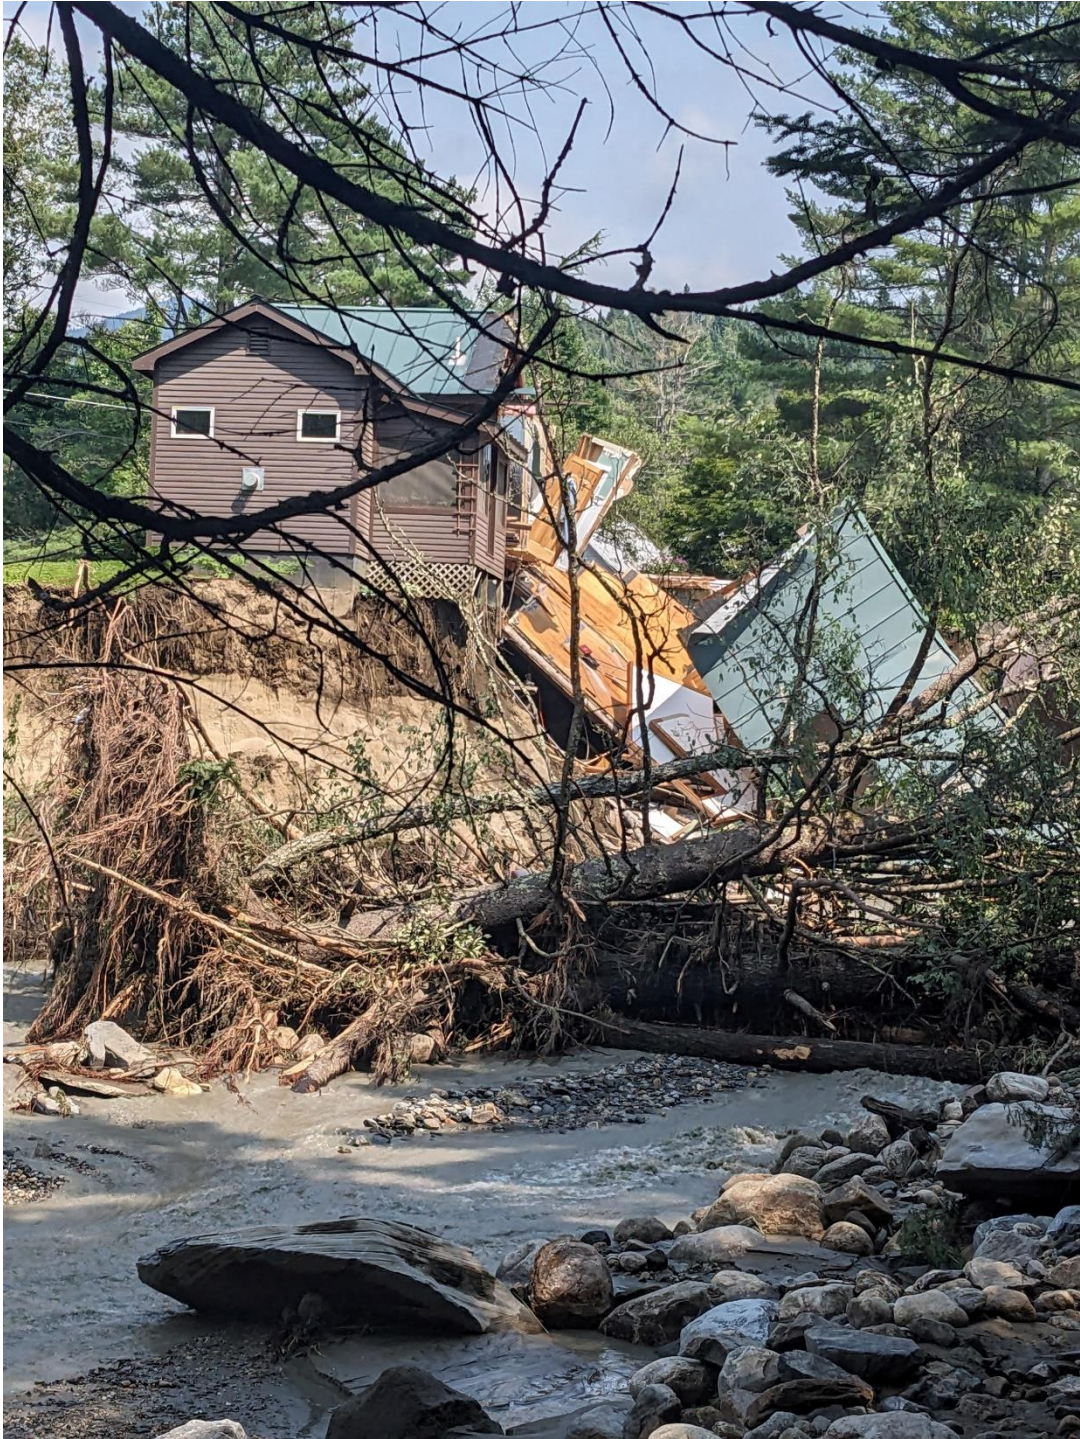
Figure 8: Catastrophic flooding washed part of this home in Lyndon away. The resident narrowly escaped with their life, being rescued from flood waters by a neighbor.
