# Preliminary Damage Survey

## **Ravenna, NE Tornado** **Buffalo & Sherman Counties**

**Date:** April 26th, 2024

**Maximum EF-Scale Rating:** EF1

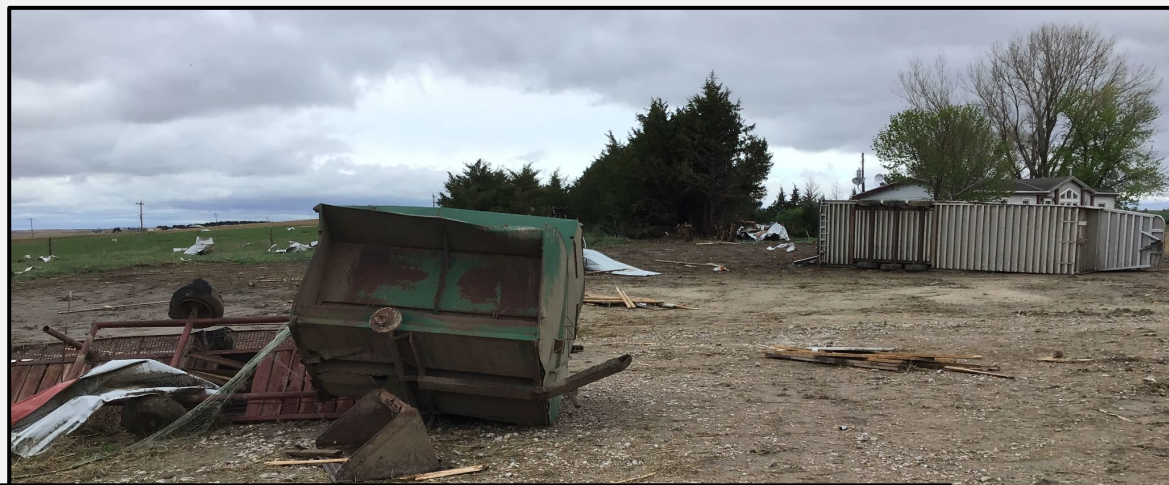
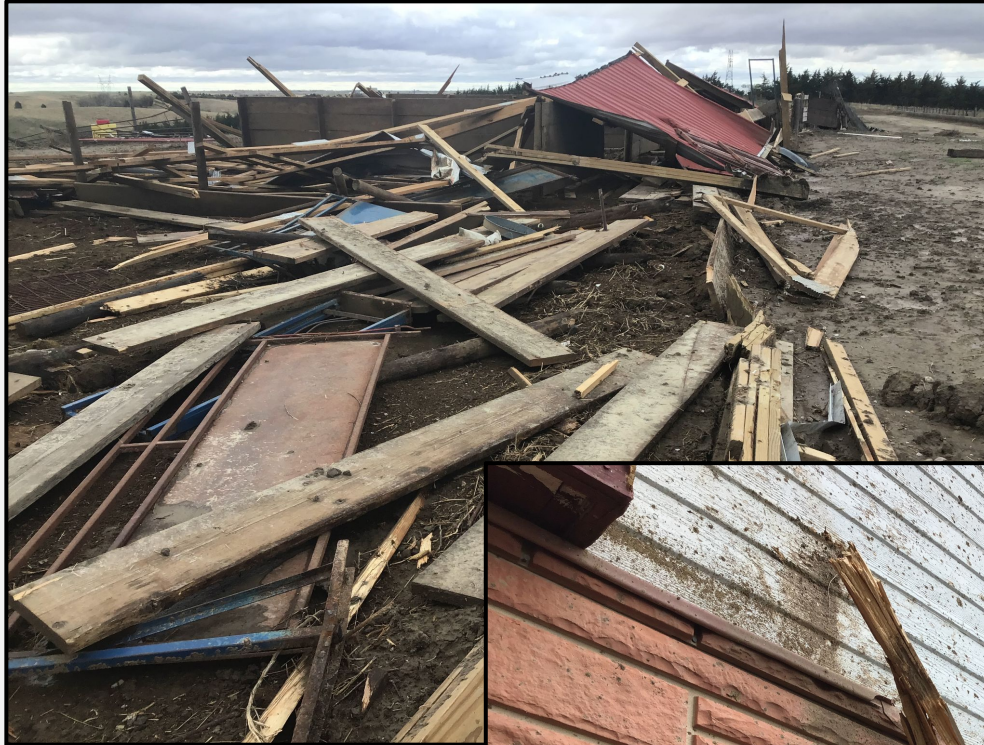
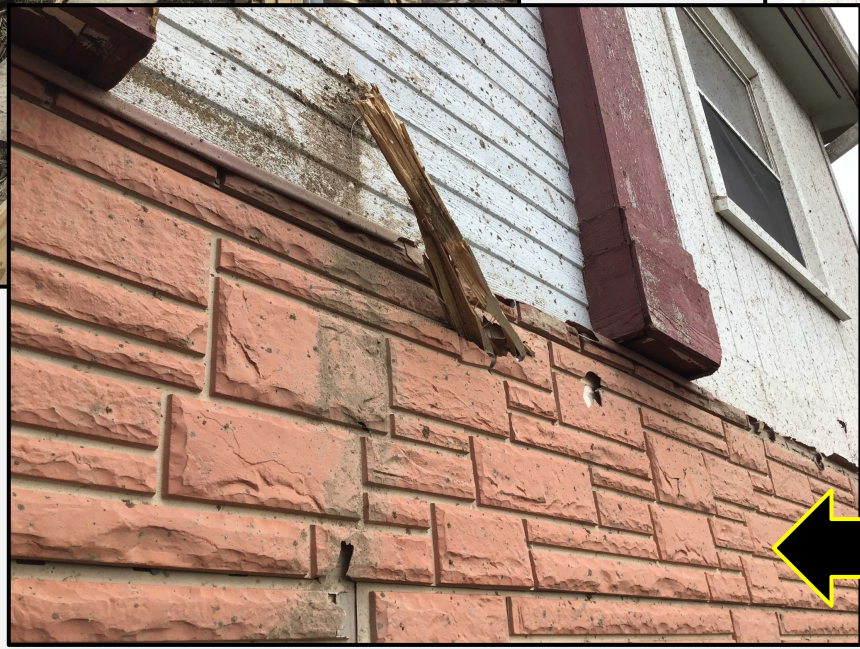
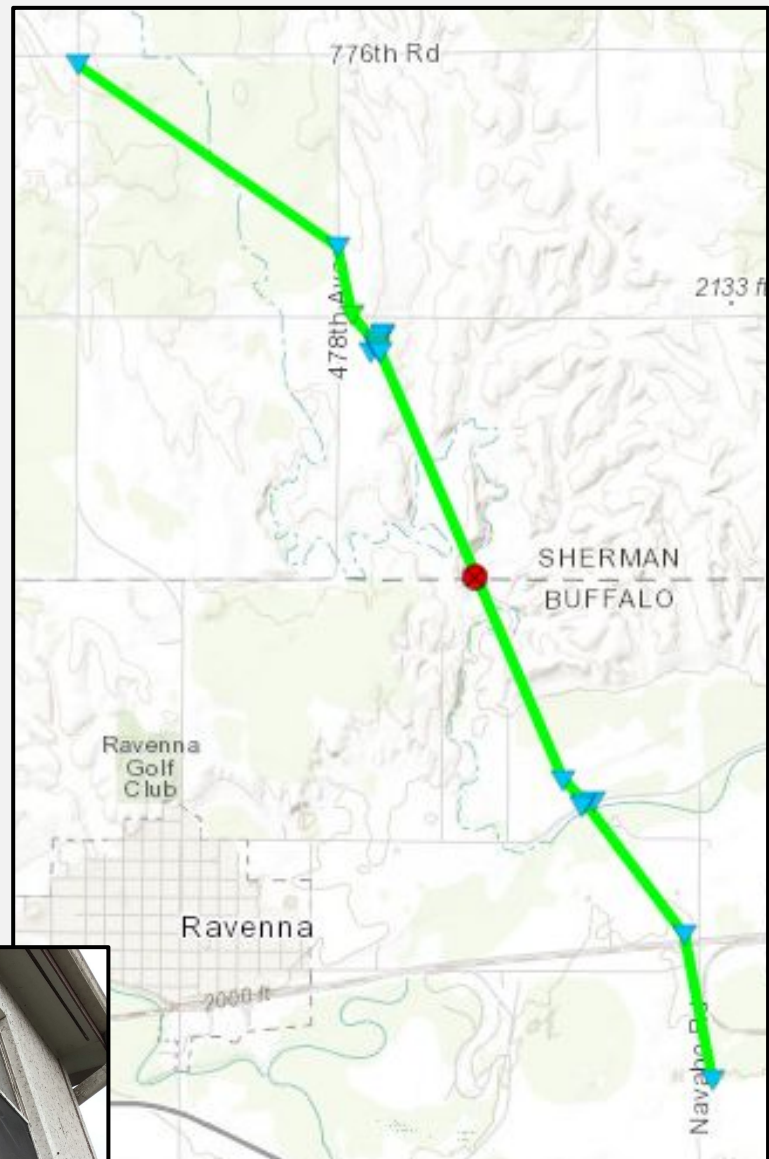
**Photos of minor home  
and vehicle damage  
at a farmstead  
northeast of Ravenna**

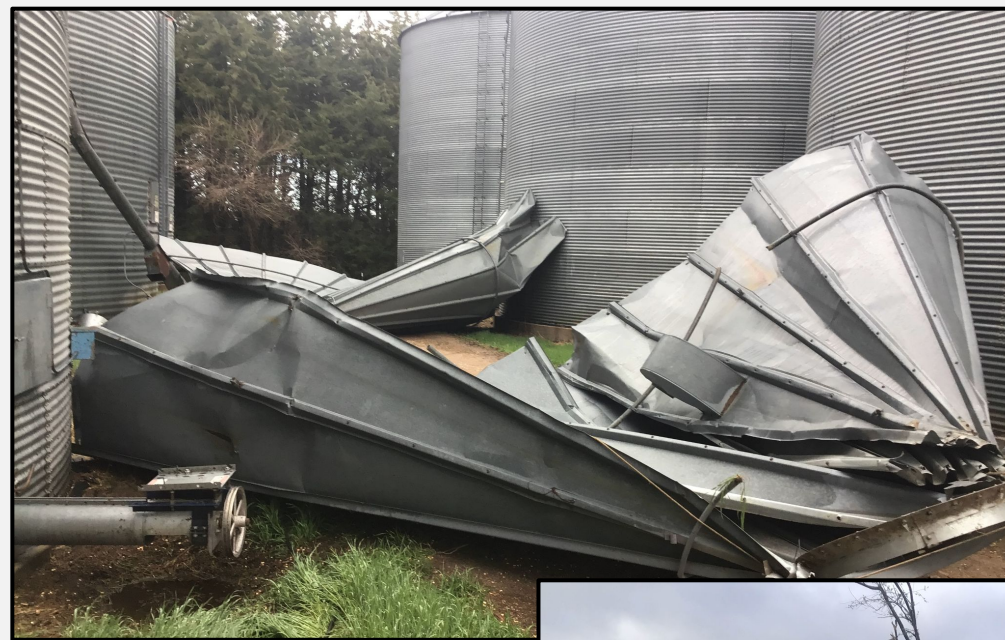
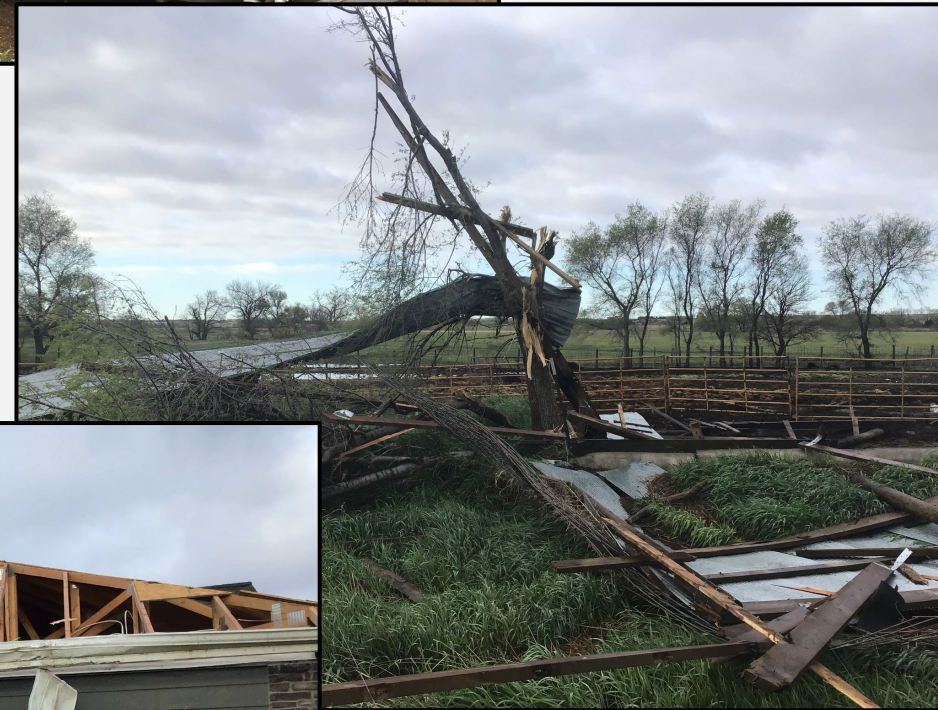
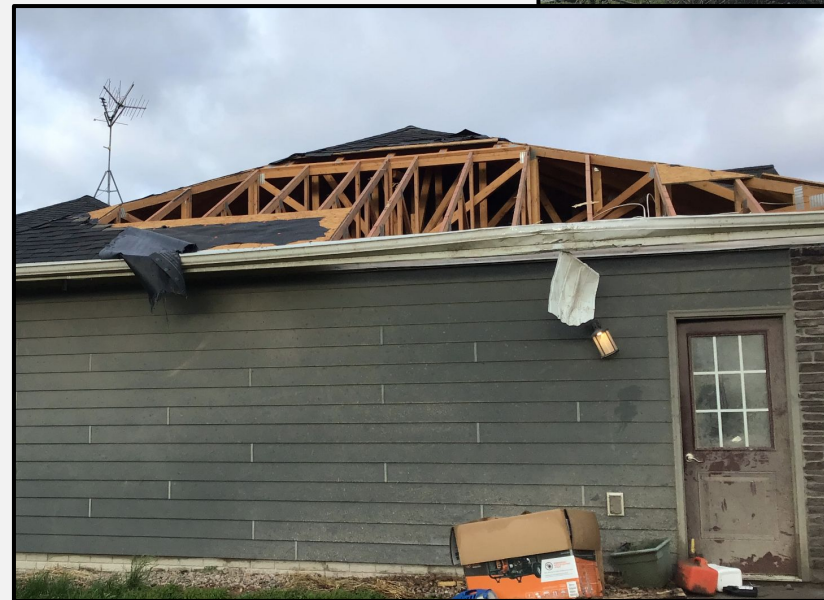
**Photos of damage  
east and southeast  
of Rockville**

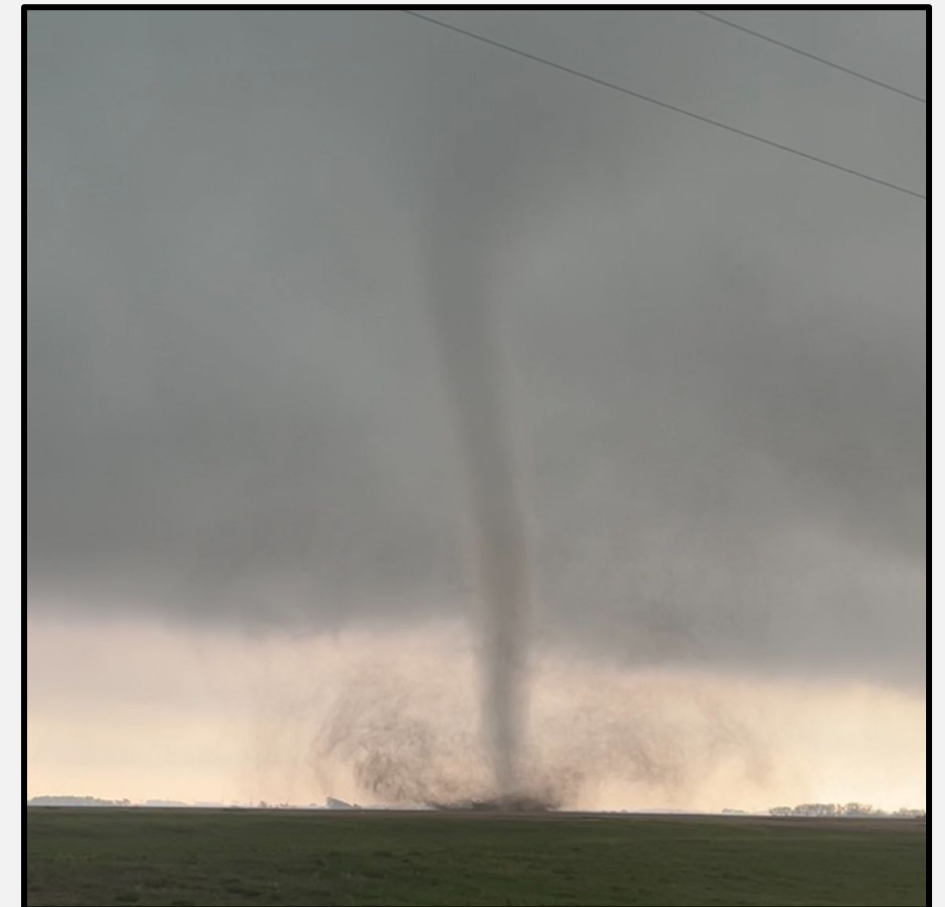
An eyewitness, who provided photos, times and detailed locations, documented a short-lived tornado south of Farwell in Howard County. This tornado occurred just prior to the development of the tornado that eventually passed near Elba.

Along its curvy path, this nearly 3 mile long tornado overturned two center irrigation pivots and damaged some trees south of Farwell. Scouring along the ground was easily visible. The tornado dissipated just south of Farwell.

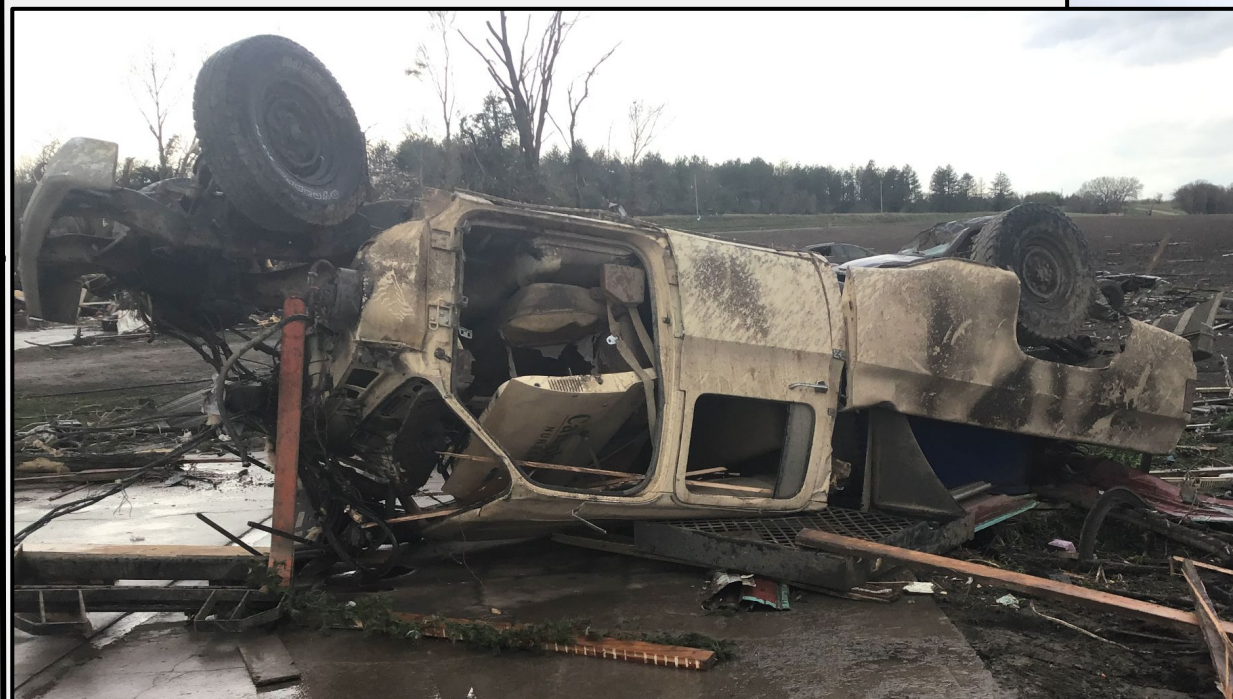
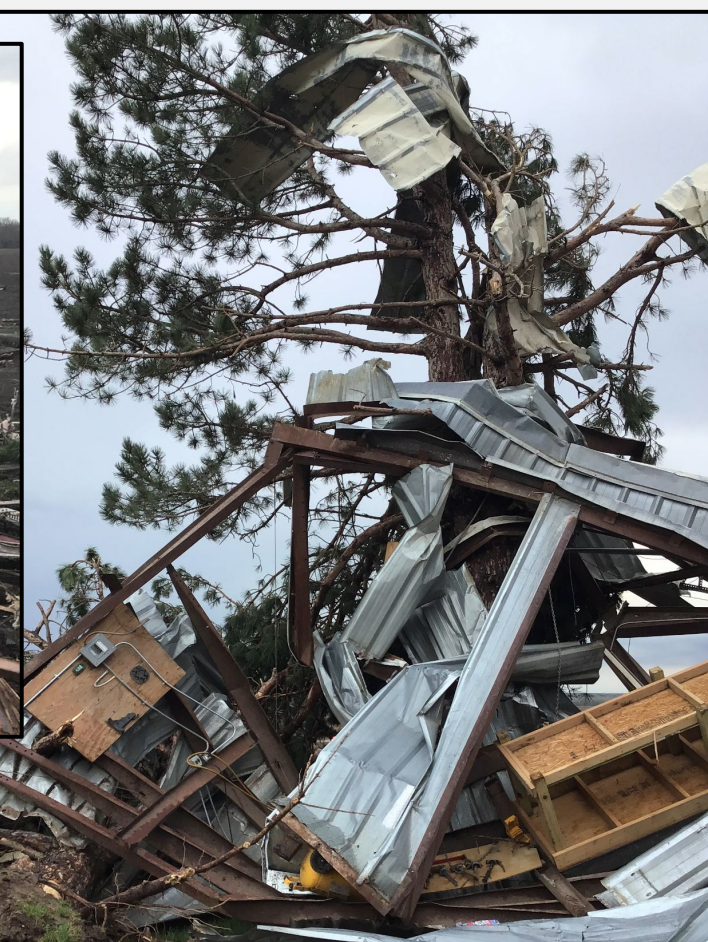
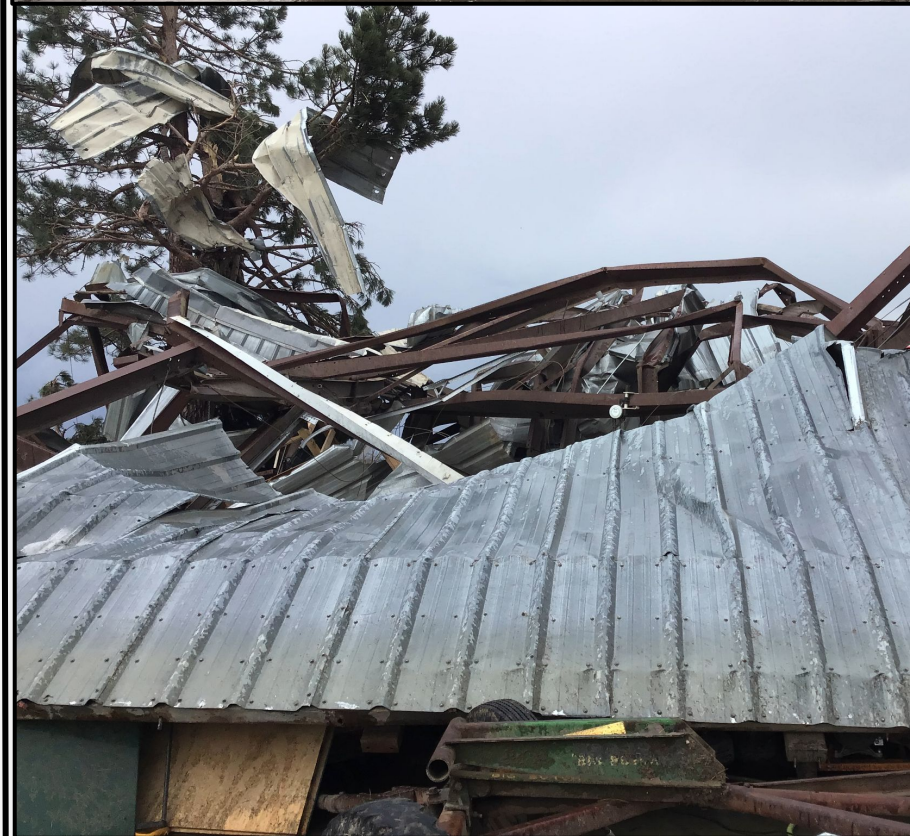
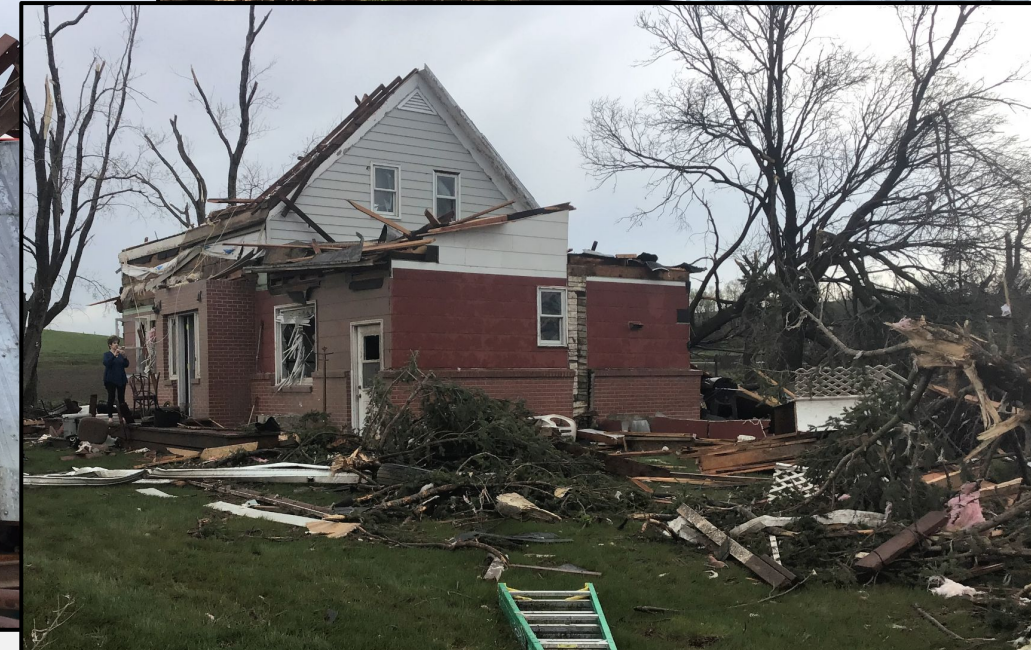
Just west of Elba, a farmstead sustained heavy damage. A well built metal building was demolished along with extensive damage to the nearby home. This location was deemed to have the strongest winds, estimated at 145 MPH.

The tornado was estimated to be around 600 yards wide as it crossed Highway 11 just northwest of Elba. A long stretch of power poles was knocked down along Odell Road.

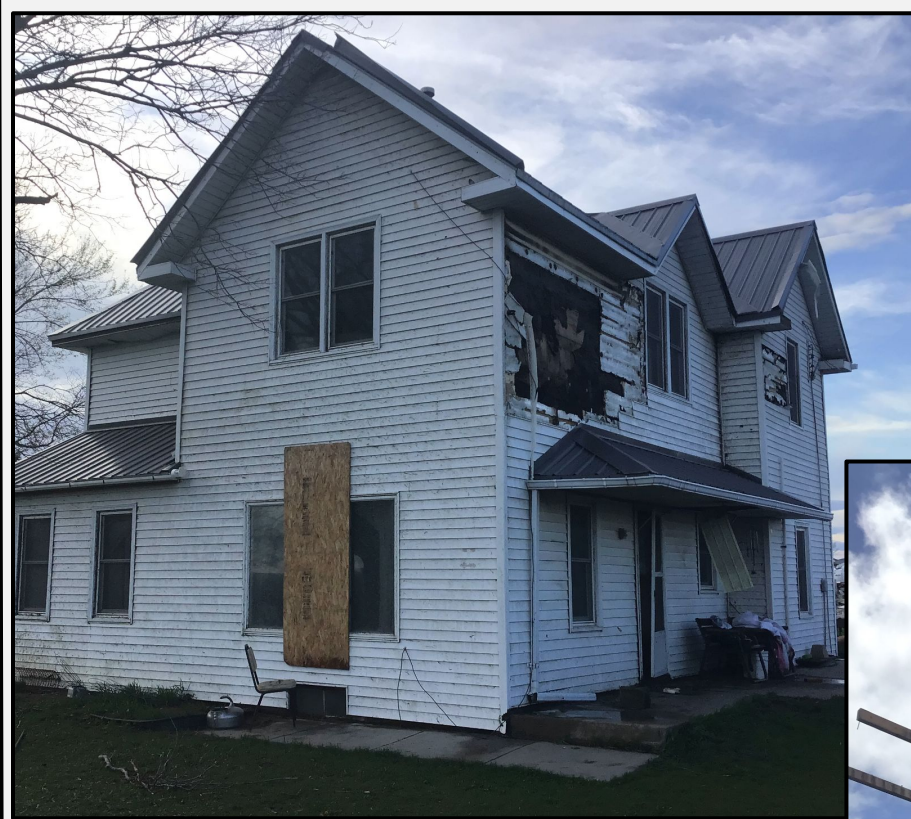
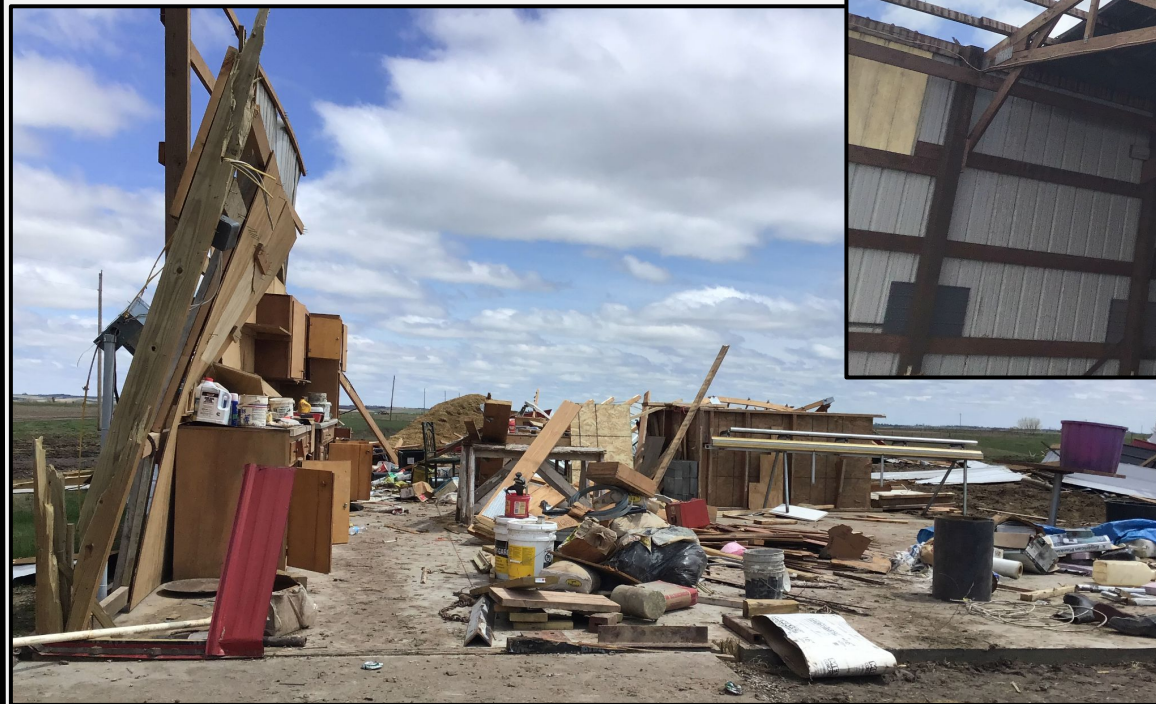
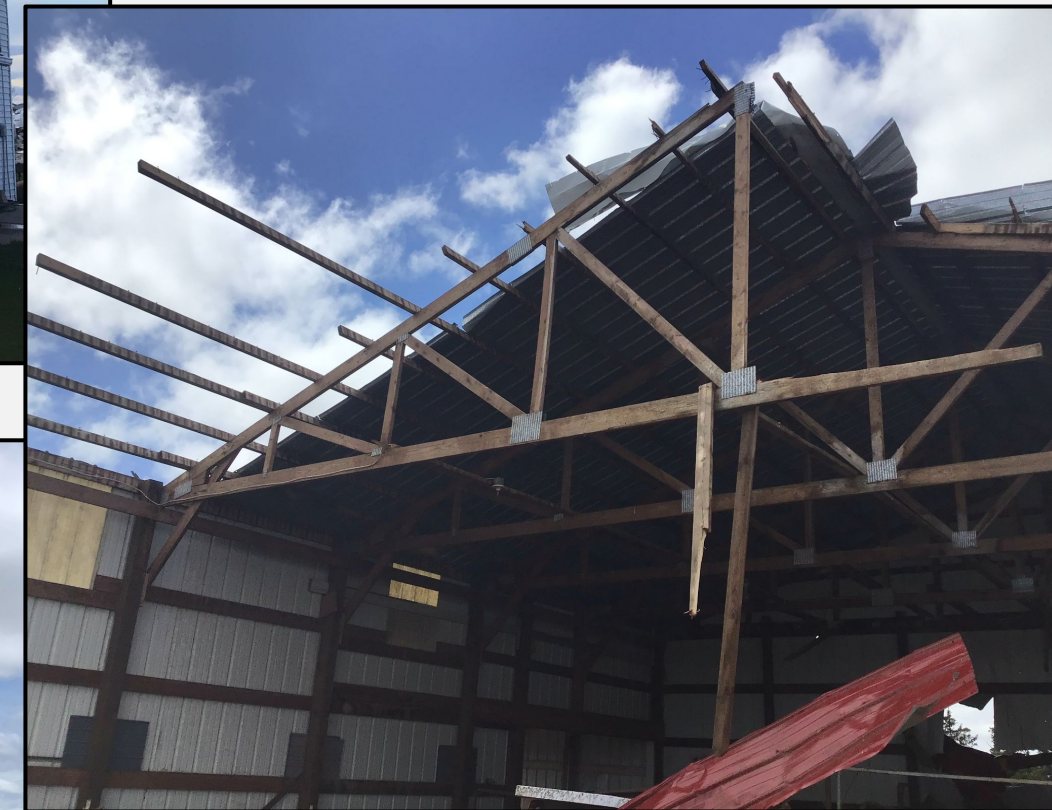
This tornado was rated an EF2 with estimated peak wind speeds of 135 MPH based upon metal power pole damage just west of the Highway 281/22 junction near Wolbach. The tornado had previously destroyed a metal building to the southwest, and would go on to destroy a couple of wood framed outbuildings to the northeast of Highway 281. The south edge of the tornado likely passed just north of the Highway 281/22 junction, and was in this general area that the tornado was at its widest. The tornado marched northeast, damaging at least one residence, outbuildings, trees and pivots.

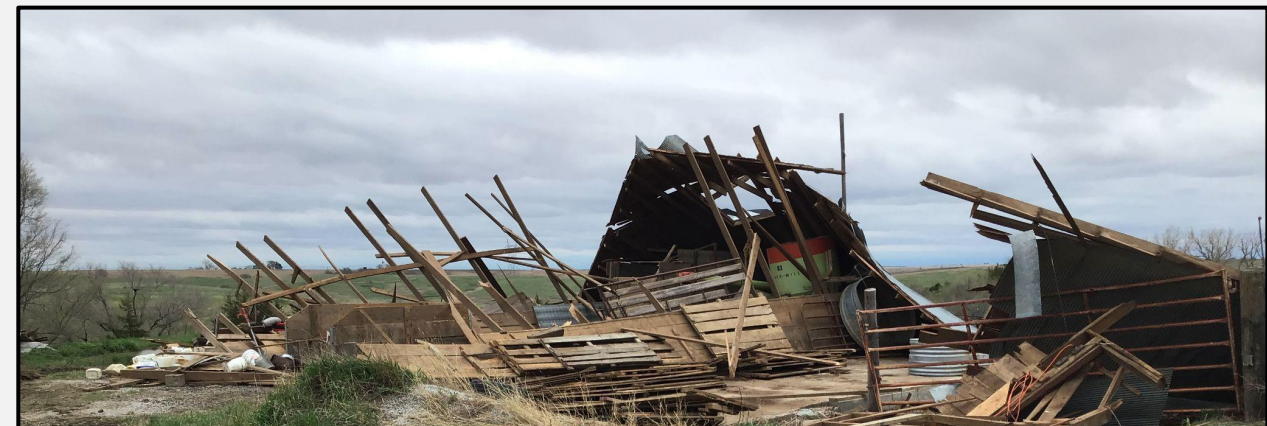
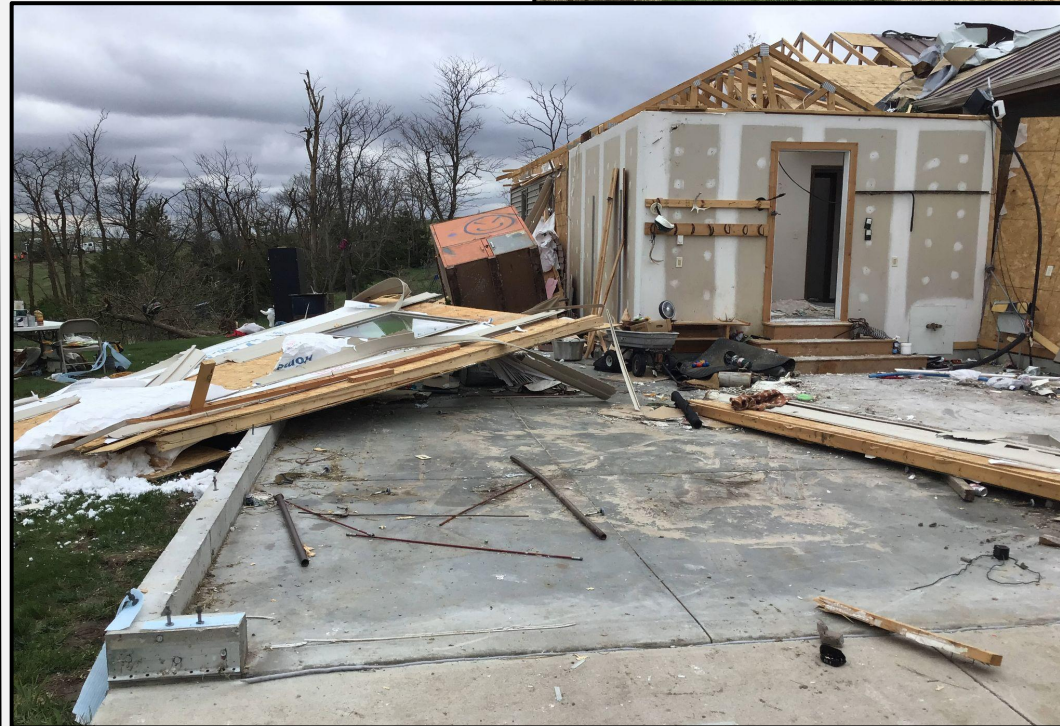
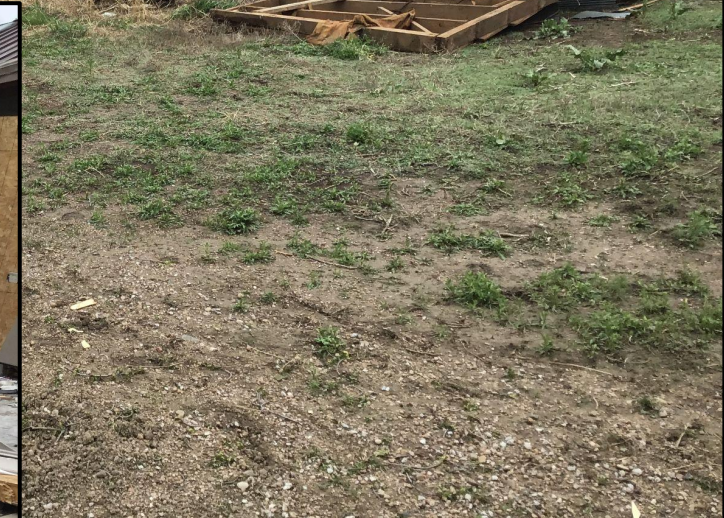
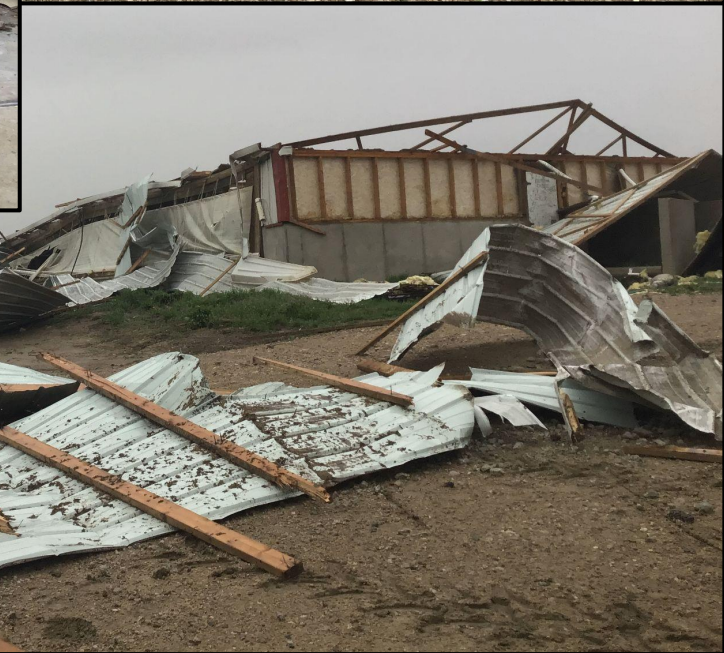
The tornado moved north and appeared to strengthen some as it flipped and tossed several center irrigation pivot systems north of Highway 56. Power poles were snapped and debris was lifted into power lines.

The tornado moved north-northeast, the most significant damage was found about 2 miles southwest of Primrose. A home was damaged, including the three-car garage being totally ripped away along with much of the roof. Several outbuildings were damaged or destroyed. Trees were damaged and power poles were snapped.

In its final few miles, the tornado damaged trees and center pivot irrigation systems in several places. Extensive damage to a livestock facility and several snapped power poles was noted about halfway between Petersburg and Primrose. The tornado likely dissipated in open country as it approached the Beaver Creek southwest of Petersburg.
