UNIVERSITY OF HAWAII

**Final Report
Tsunami Observer Program
and the Tsunami of March 11, 2011**

Award Number NA09NWS4670016

September 2012

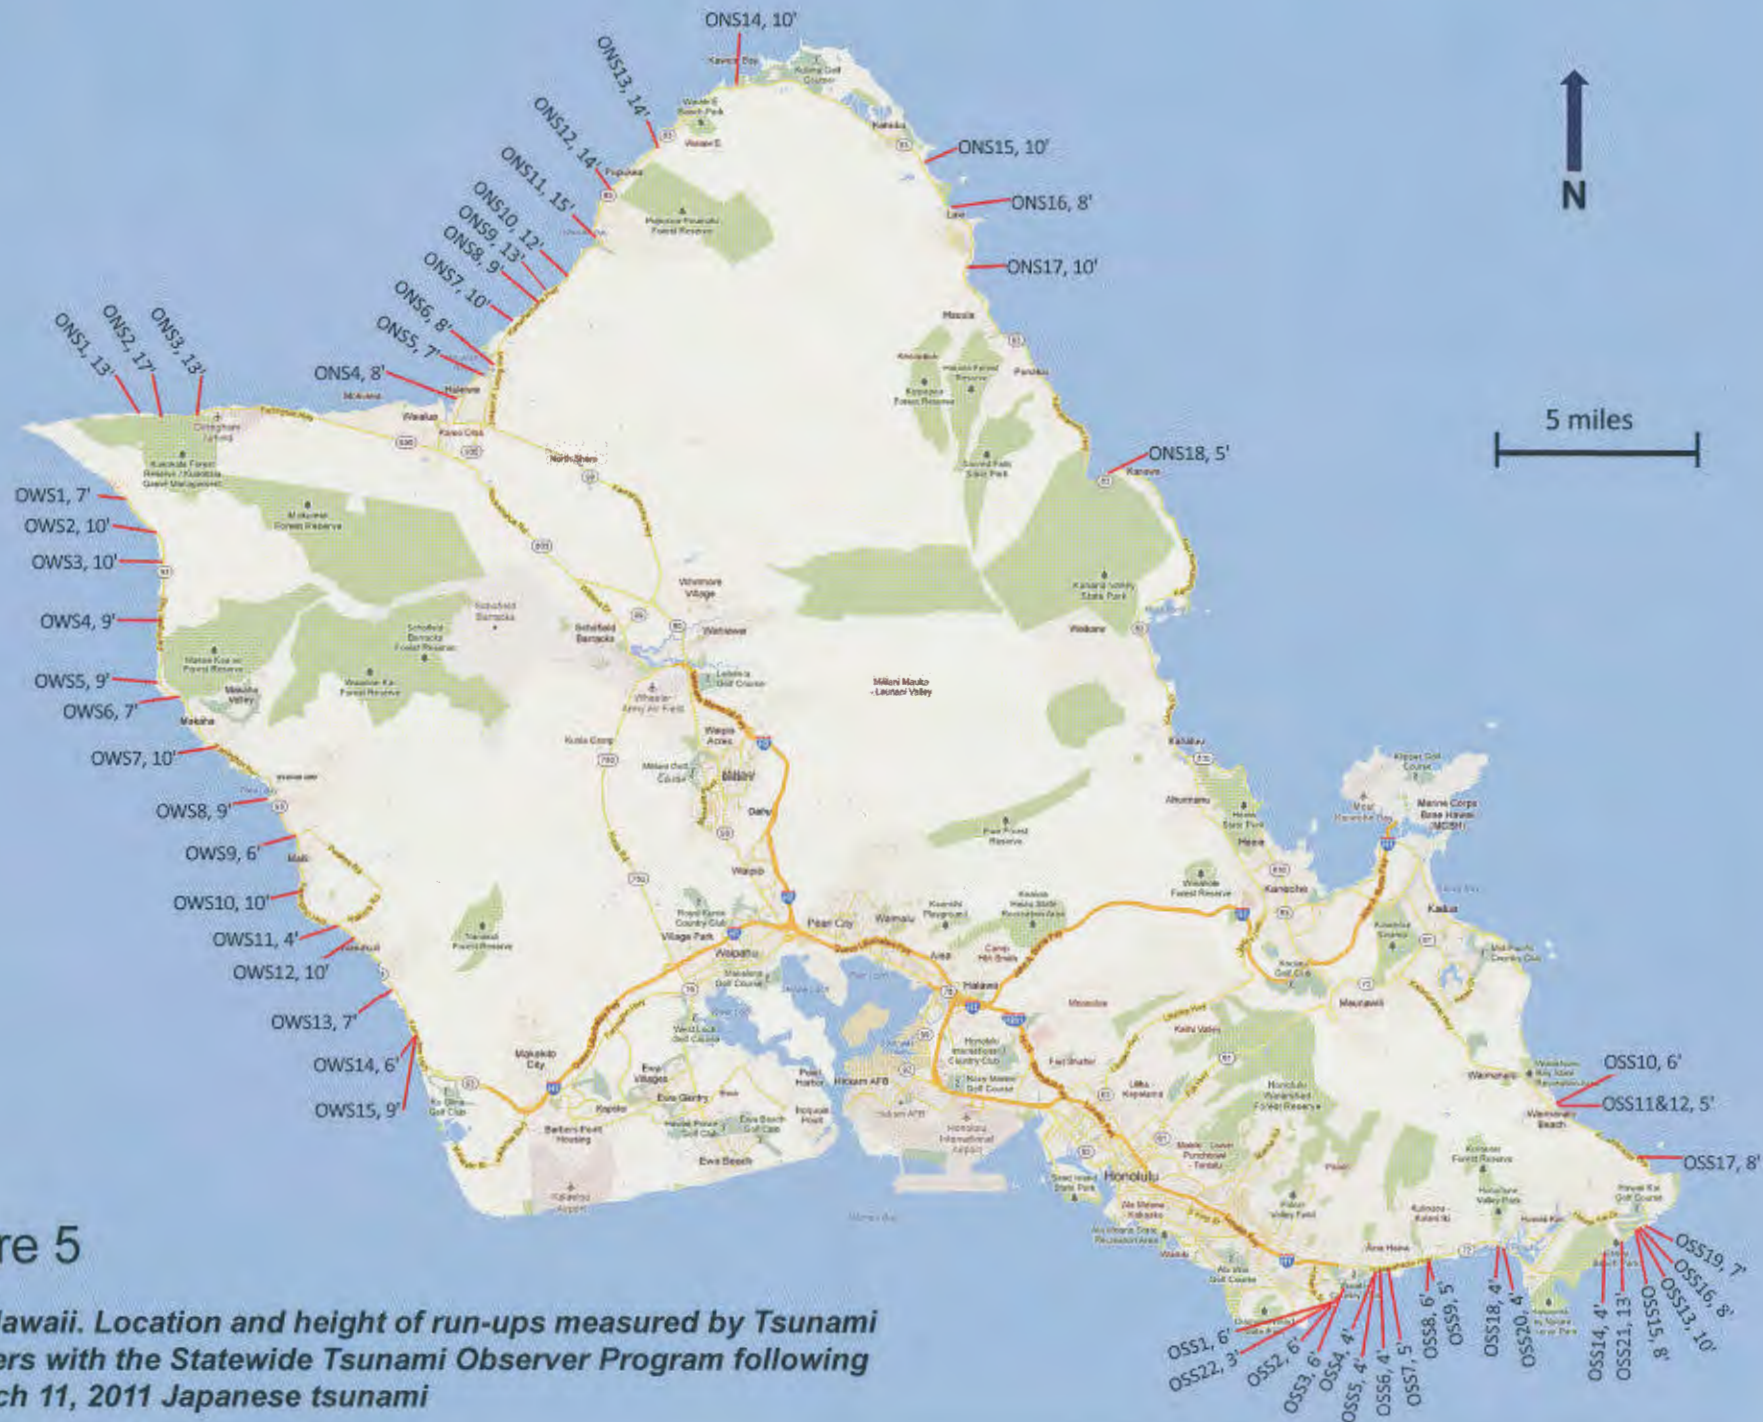
Figure 5

Oahu, Hawaii. Location and height of run-ups measured by Tsunami Observers with the Statewide Tsunami Observer Program following the March 11, 2011 Japanese tsunami

Highest run-up on the Island of Oahu was measured at about 17 feet just NW of Camp Erdman on the north shore (ONS2) by Dan Walker and his team. The entire north shore experienced higher run-up values than any of the other shorelines (table 1). The Mader/Miller team reported about 10 feet just seaward of the traffic signal at the intersection of Hawaii Kai Drive and Kalaniana'ole near Sandy Beach (OSS13). The Keating/Helsley team reported an estimated (not measured) run-up of 13 feet at the far eastern end of Queens Beach near the inlet (east of OSS19). Other high values were recorded at Baby Makapu'u (OSS17) by the Miller/Yamada team of 8 feet, and the Donelle and Bill Lennan team measured a run-up of about 13 feet at Sandy Beach (OSS21). Run-ups along most of the southern coast along the Maunalua Bay to Kahala beach area were made by Volker and Schloesser and Miller and Watkins and ranged from 5-6 feet (OSS7-OSS9). Run-up

and Inundation limits along the western shore of Oahu were diligently recorded by Mark Suiso. Maximum run-up on this western shore was measured at about 10 feet at Hakimo (OWS12), Mailiili (OWS10), Makua North (OWS3), and Makaha (OWS7). Several other areas along this shoreline had run-ups of 7 and 9 feet with a mean value of 8 feet (OWS4, OWS6, OWS8, OWS13, OWS15).

Inundation limits were more difficult to measure accurately due to the slopes of the beaches. In addition, conspicuous 5 to 10 minute period oscillations of sea level were observed for several days following the quake adding to the difficulty in estimating sea levels at the time of the measurements. Inundation limits ranged widely from the 27-67 feet inundations measured off Kahala beach areas (OSS2, OSS9) to almost 250 feet at the parking area adjacent to Maunalua Bay (OSS18, again a reflection of the relatively flat slope of the shoreline).

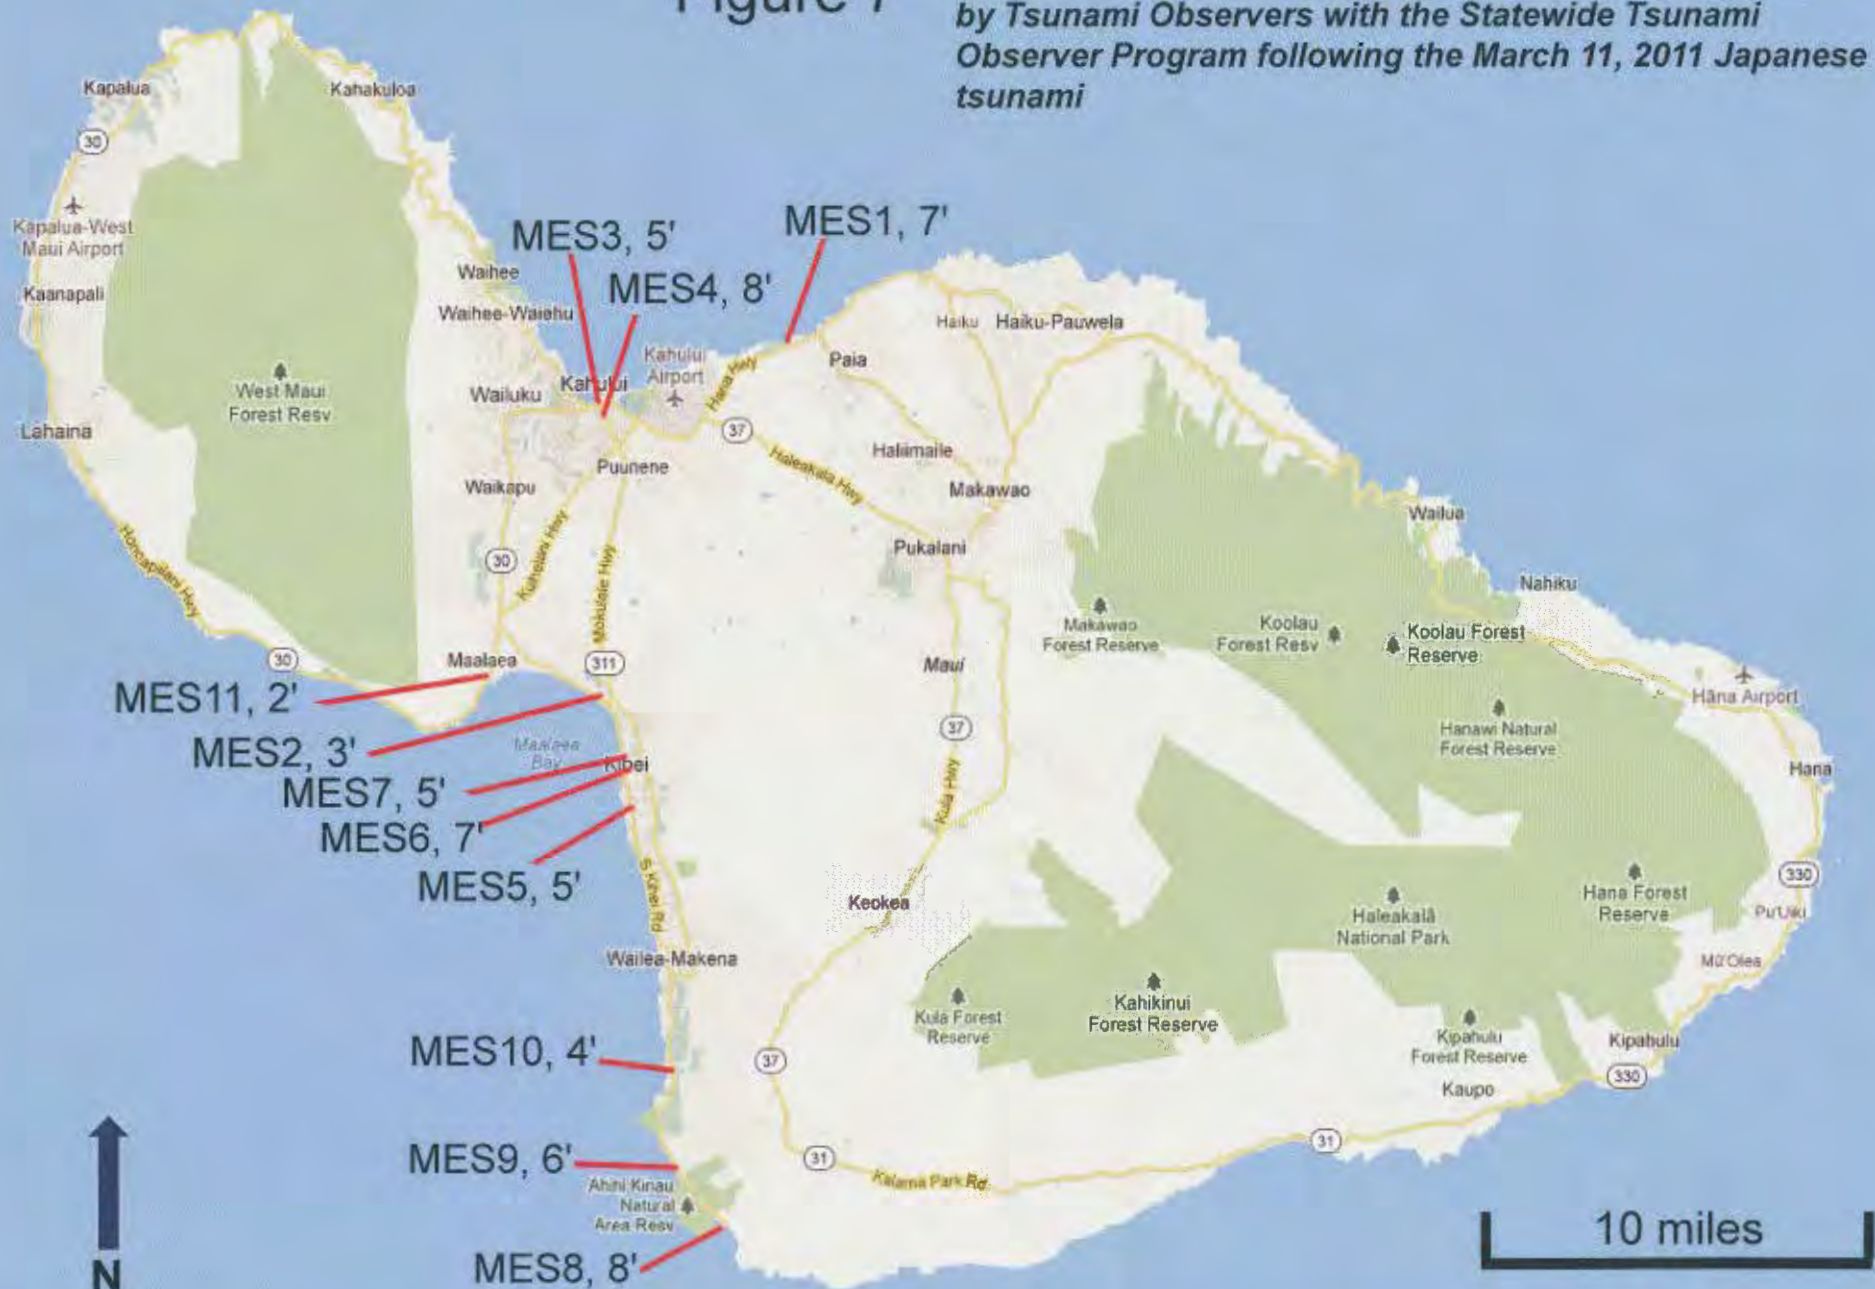
Figure 7 *Maui, Hawaii. Location and height of run-ups measured by Tsunami Observers with the Statewide Tsunami Observer Program following the March 11, 2011 Japanese tsunami*

David Grooms, the TOP leader for Maui, was able to guide his team of observers to make measurements of run-up and inundation at several locations on Maui. They recorded maximum run-up at La Perouse Bay of 8 ft 3 inches (MES8) and maximum inundation inland of 156 feet.

Joseph Fell-McDonald reported a run-up height at Kanahena cove Ahihi Bay at 6 feet with 22 feet inland inundation (MES9) and a run-up height of 4 feet 4 inches occurred with an inundation distance of 18 feet at 7299 Makena Alanui Drive (MES10). On March 16, 2011 he also reported that wave run-up height reached a maximum at La Perouse Bay of 8 ft 3 inches. Maximum inland inundation was measured at 156 feet (MES8).

In addition to the individual measurements and reports cited above, informal observations were reported by Maui TOP leader David Grooms for Kahului Harbor and nearby coastal areas. Runup was 5 feet along Puunene ave (MES3). Inundation along Puunene ave was approximately 0.2 miles from the coast line at the Hideaway restaurant (Latitude 20° 53.513' N; Longitude 156° 28.094' W.) to the McDonalds (MES4) across from the Puunene Post Office just south of Kamehameha Ave. Some damage was experienced by the Hideaway restaurant and the east-west trending fence was torn apart, along the northern border of the parking area of the old site for the Superferry. Some cars within the lot were moved and banged against each other. Water entered the parking areas of both the Hideaway restaurant and 1st Hawaiian Bank just to the south. He found no other noticeable locations of inundation around Kahului Harbor. David Grooms also reported that most boats left Maalaea harbor in response to the tsunami warning from Civil Defense. Some damage was experienced by those that remained. Water washed over the breakwater at Maalaea Harbor and left debris scattered along the roadway. Some boulders and wood structures were moved as much as 30 feet (MES11).

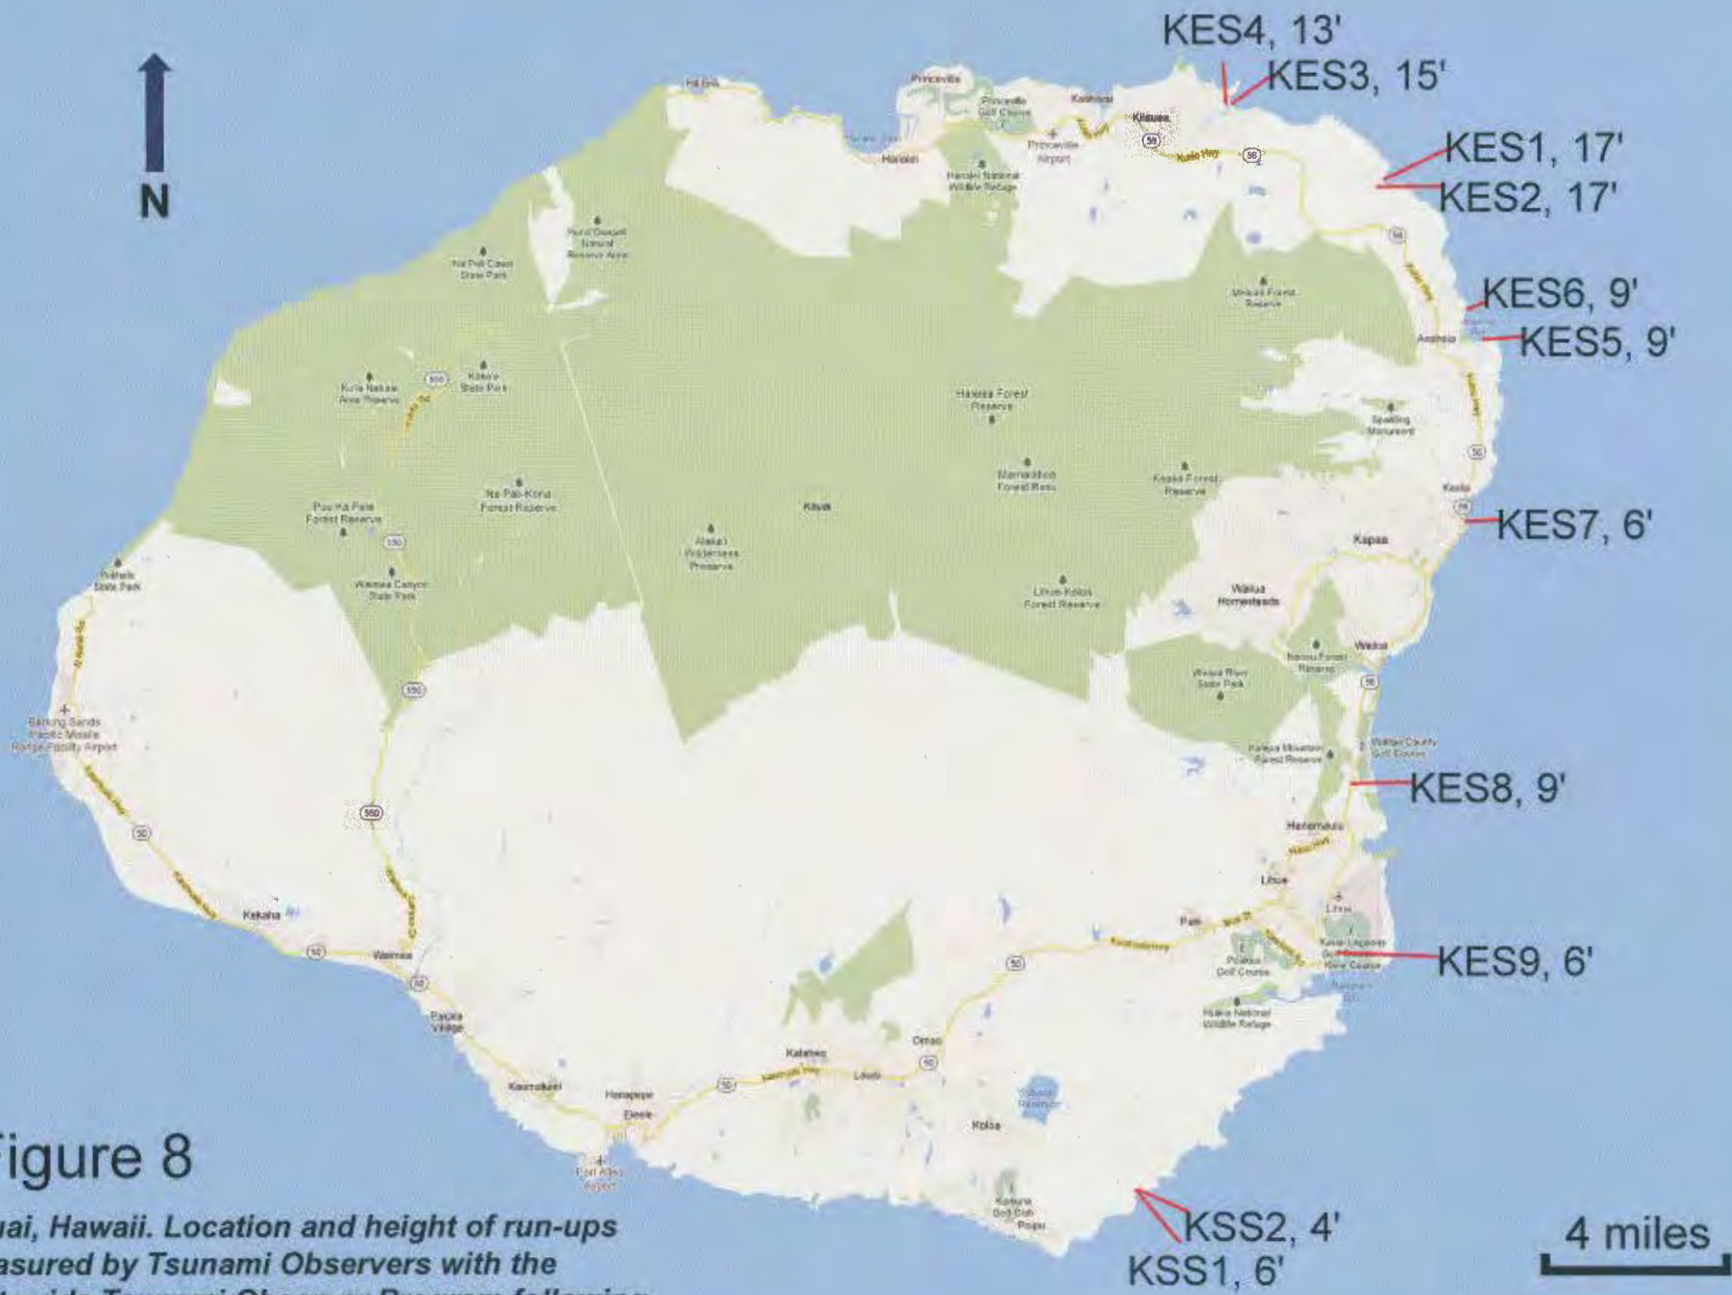
Figure 8

Kauai, Hawaii. Location and height of run-ups measured by Tsunami Observers with the Statewide Tsunami Observer Program following the March 11, 2011 Japanese tsunami

Run-ups on the east side of Kauai reported by the team of Blay and Siemers were substantially higher than those observed at most areas on Oahu, and ranged from a high of 17+ feet at Moloaa Bay (KES1, KES2) to about 9 feet at the Anahola Beach near the lifeguard station (KES5). The few observations from the South side gave values of from 3-8 feet (KSS1, KSS2, KES9, KES8).
