TECHNICAL REPORT CERC-87-10

HURRICANE ELENA STORM SURGE DATA

Report 3

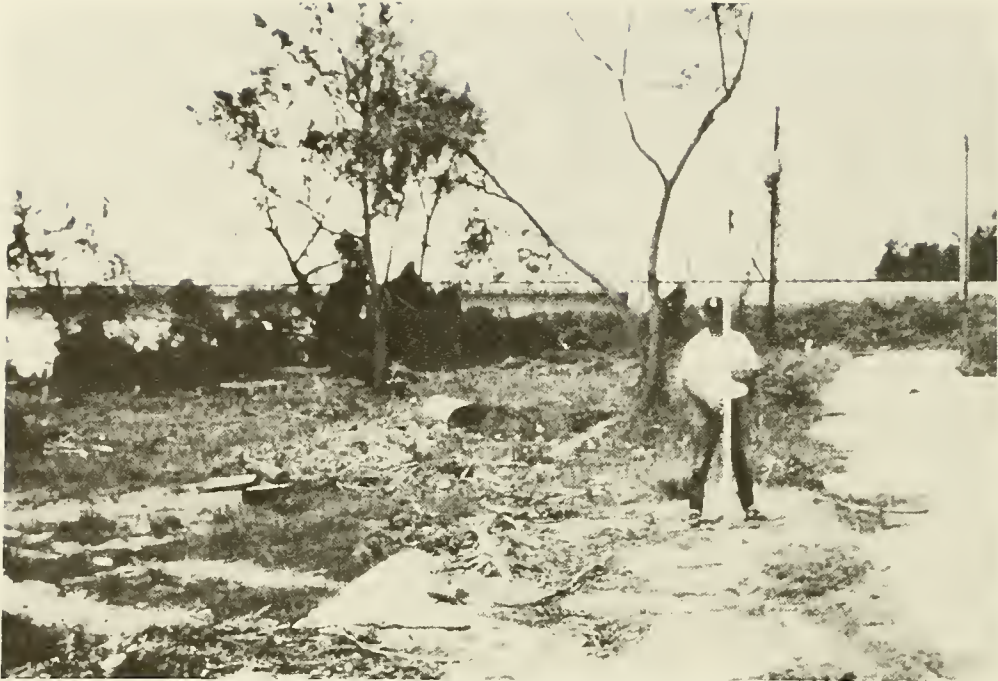
14. Trash lines remained all around the shores of Biloxi Bay. On the eastern side of the bay at the location of the Biloxi fishing bridge (the remnant of the old Highway 90 bridge), the surge washed across part of a shore-front road. Photo 1 shows this trash line being surveyed. The elevation of the surge induced flooding did not exceed +3 ft NGVD at this point.

Photo 1. Surveying debris line at the east end of old Highway 90 fishing bridge, Biloxi, Miss.

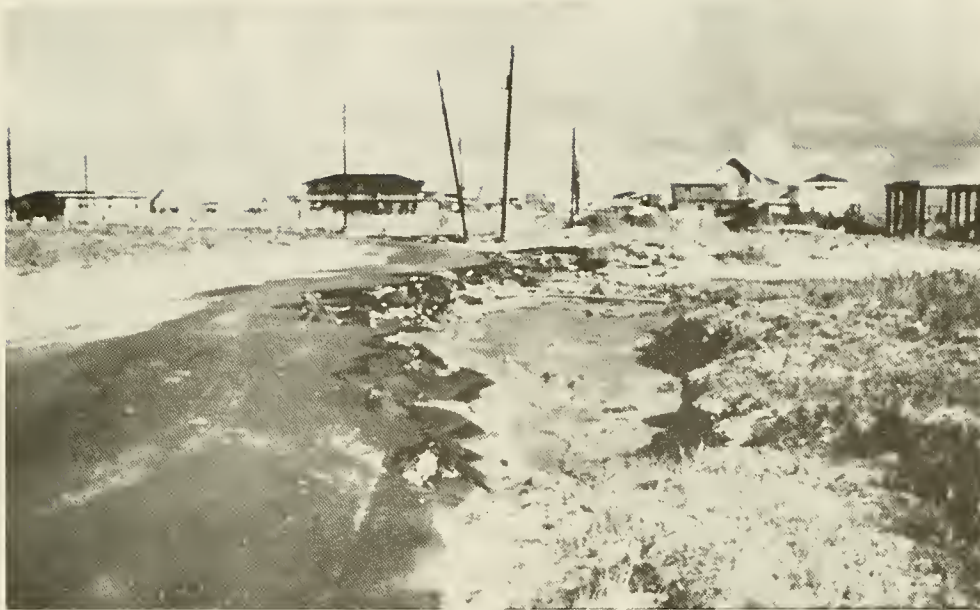
16. The hardest hit area on the coast was Dauphin Island, Ala., which was directly in the path of the hurricane's track just prior to landfall. There was extensive wind damage all over the island, but the majority of the damage caused by the surge was seen on the western half of the island where the surge passed completely over the island at a number of locations. This resulted in gullying which damaged roads (Photo 3) and undermined the foundations of houses (Photo 4). The high-water mark at these locations measured +6.5 ft NGVD. The small-boat harbor on the northeast side of the island suffered very little structural damage, but some of the boats were damaged or sunk when they broke free of their moorings (Photo 5). The only major surge-induced damage on the eastern end of the island occurred at Pelican Point where the deck of the wooden pier supporting the NOS/CE surge gage was destroyed (Photo 6). The high-water level at this location was about +6.7 ft NGVD with wave runup heights exceeding +8.0 ft NGVD.

Photo 3. Damage to road on north side of Dauphin Island, looking west

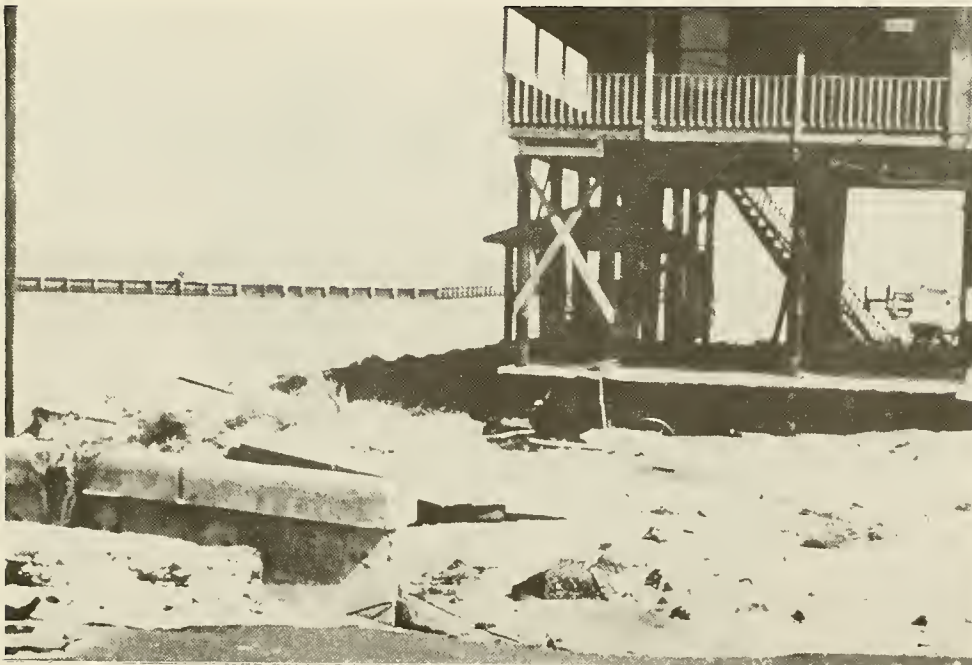
Photo 4. Foundation damage on the western half of Dauphin Island, bay side

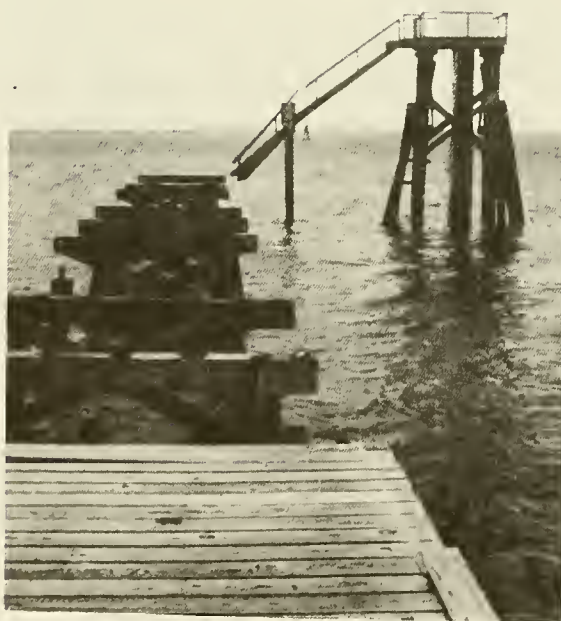
Photo 6. Pier damage at Pelican Point on the eastern end of Dauphin Island showing the NOS tide station where hydrograph of Dauphin Island (2) was obtained

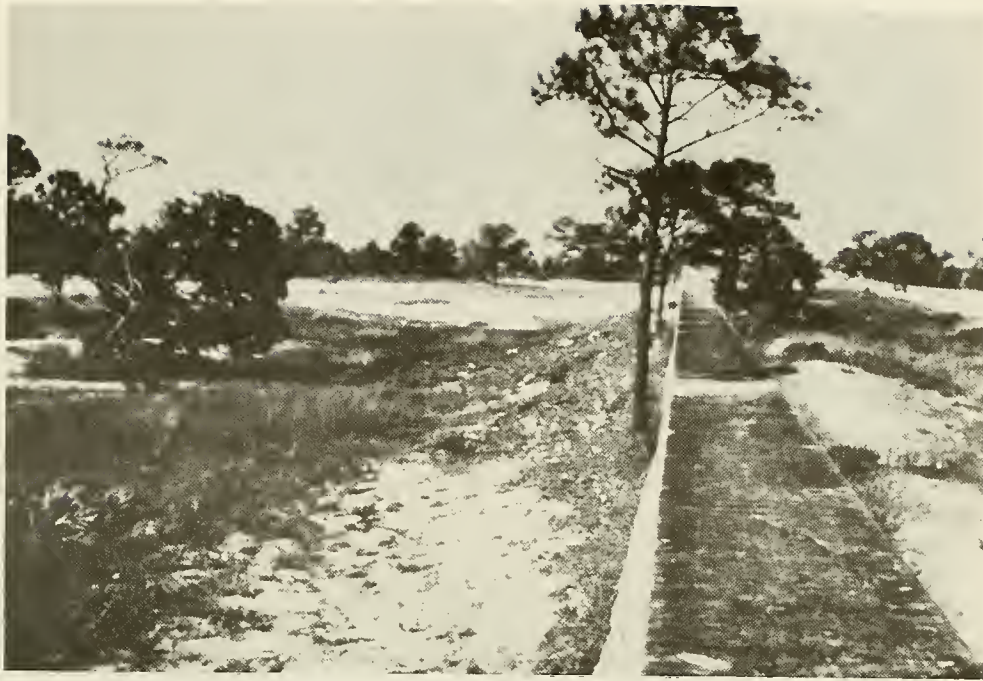
entrance to Mobile Bay exceeded +8 ft NGVD and reached the base of the seawall in Fort Morgan State Park (Photo 7). Within the boundaries of the state park, there were several locations where the surge passed completely over the spit, resulting in highway erosion (Photo 8). While surge related damage was confined to the highway, high winds totally destroyed one building and severely damaged several others in the park. Surge elevations dropped rapidly east of the park to an average of +4 ft NGVD. This was sufficient to cause some flooding in the communities located between the park and the city of Gulf Shores. However, the amount of structural damage was minimal as can be seen by the house shown in Photo 9.

Photo 7. Debris line at the foot of the seawall,
Ft. Morgan State Park, Ala., looking west

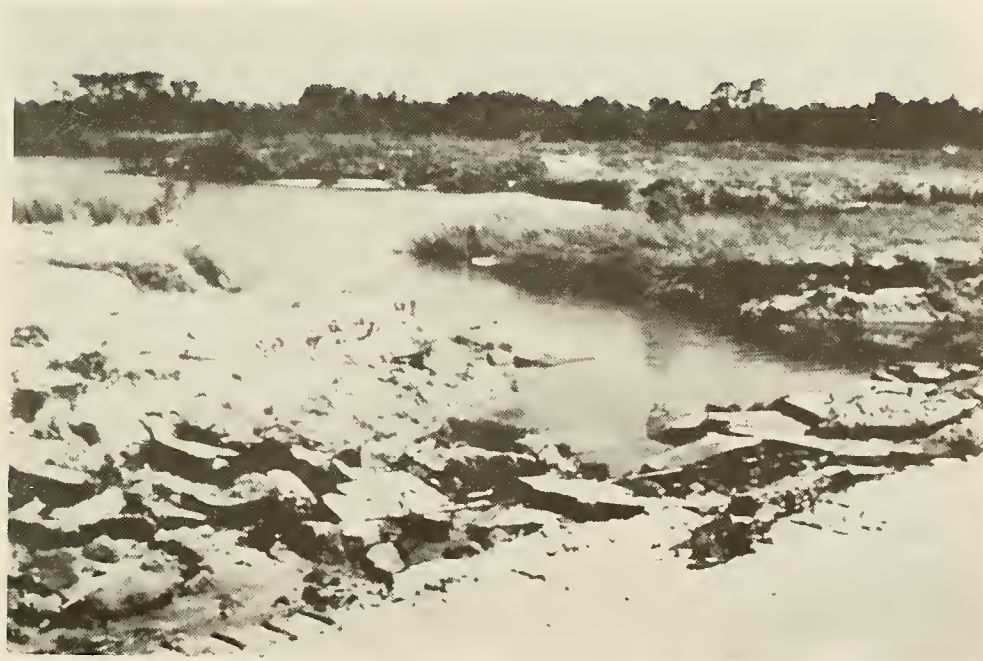
Photo 8. Evidence of overwash resulting in road damage in
Ft. Morgan State Park, looking north

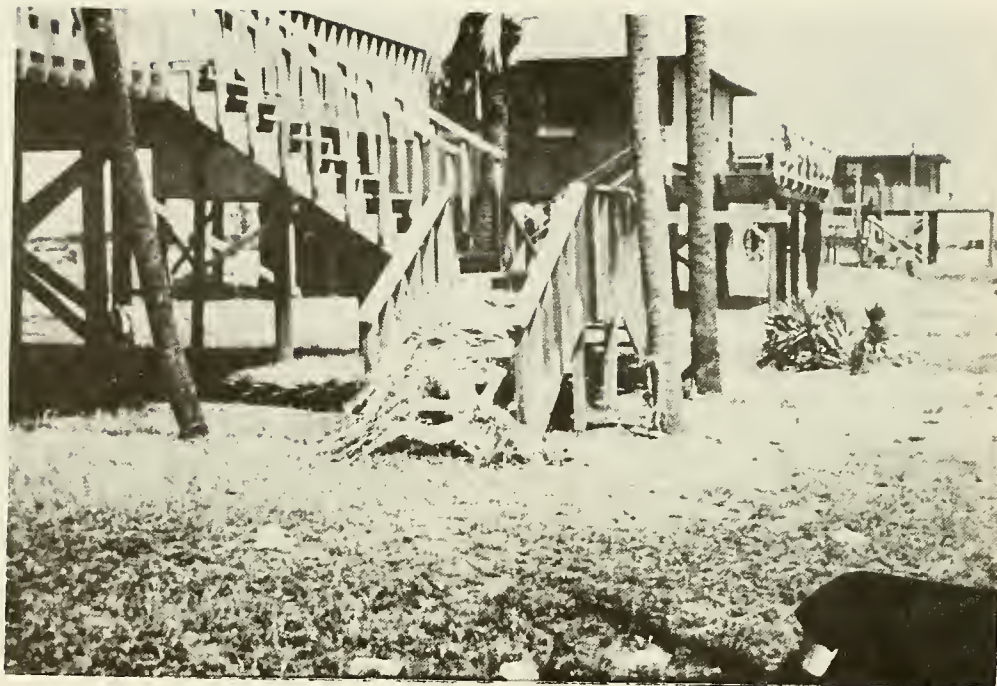
Photo 9. Debris line on house steps near Gulf Shores, Ala.

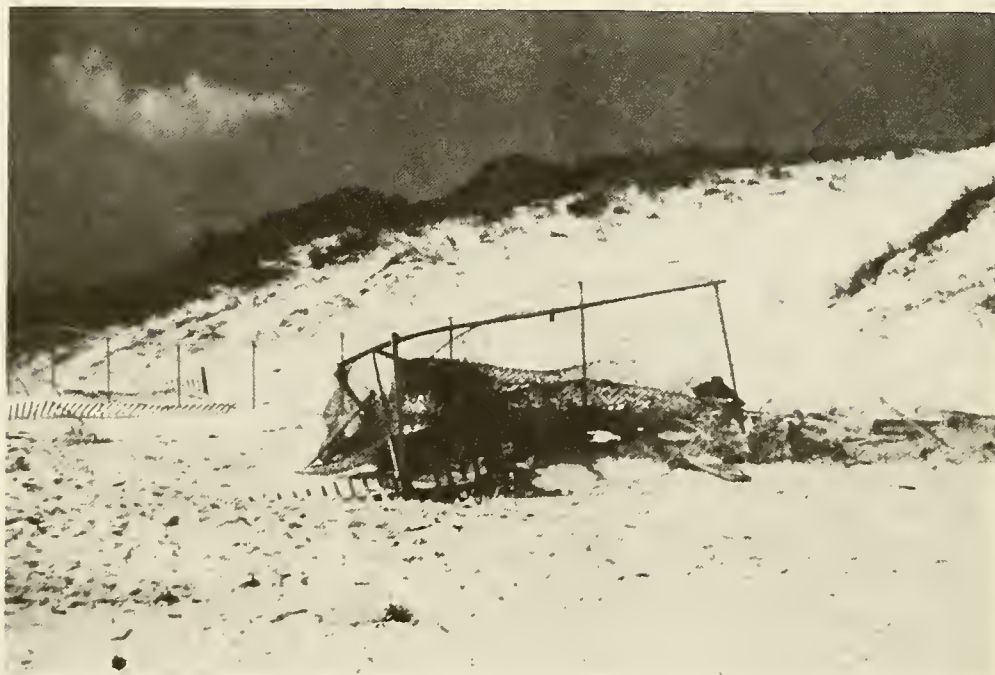
18. Throughout the western part of the Florida panhandle the measured high-water marks were less than +5 ft NGVD. Thus, actual damage resulting from surge was limited to minor highway damage and to structures located very close to the high-water mark such as the chain link fence in Pensacola Beach shown in Photo 10. In Destin, the surge and wave runup cut through a dune line (Photo 11) and flooded a lagoon located behind the dune line. The water level in the lagoon rose approximately 5 ft but did not flood any of the structures surrounding it. Farther east along the coast, surge levels continued to diminish with most high-water marks at an elevation of less than +4 ft NGVD. However, some damage did occur at several locations. One such location was the Dan Russell City Pier in Panama City Beach, Fla. The concrete decking on the end of the pier was lifted and broken by waves (Photo 12). This damage occurred at an elevation of approximately +20 ft NGVD, at a location where the measured wave runup did not exceed +10 ft NGVD, and is probably the result of the seaward end of the pier being in the breaker zone during part of the storm.

Photo 10. Damage to chain link fence in front of dune line at Pensacola Beach, Fla.

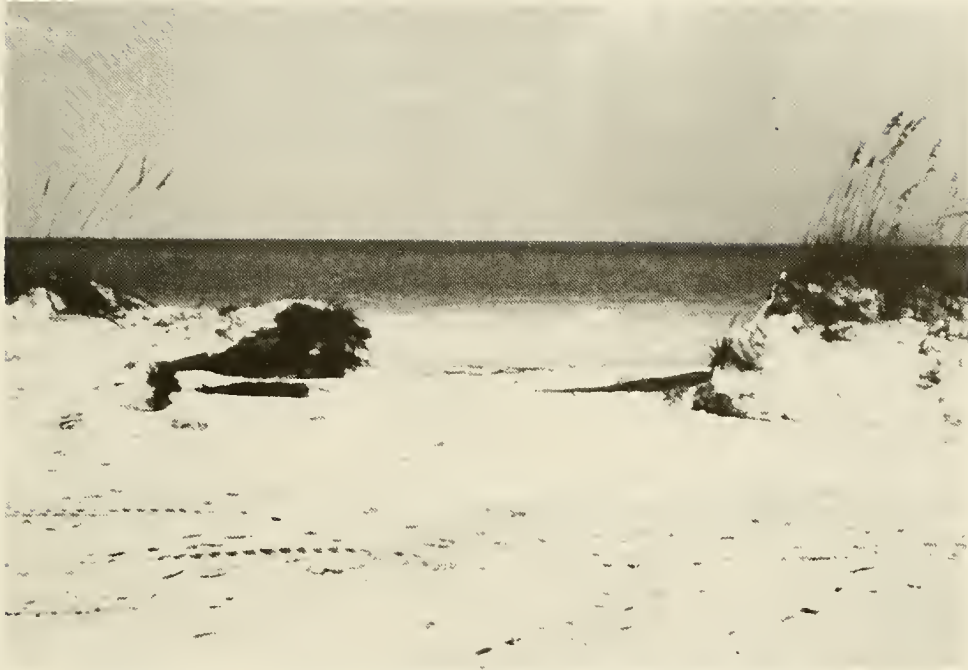
Photo 11. Cut through dune line in Destin, Fla.,
looking south

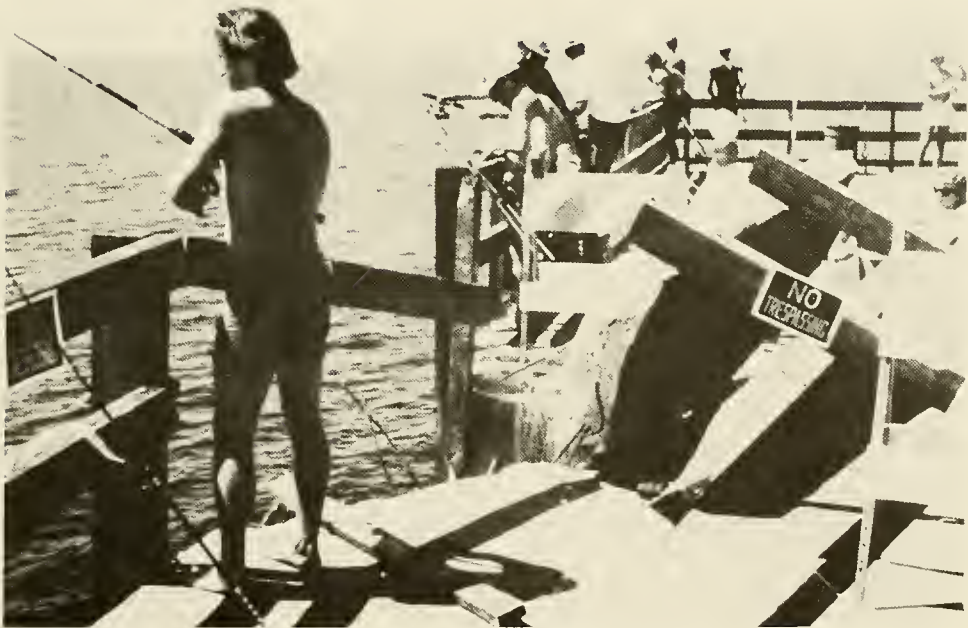
Photo 12. Damage to the decking of Dan Russell City Pier at
Panama City Beach, Fla.
