OVERVIEW:

- The Overall Flood Outlook is **Normal** for Eastern and Northern Maine
- The Ice Jam Threat has **Ended** for All of Eastern & Northern Maine.

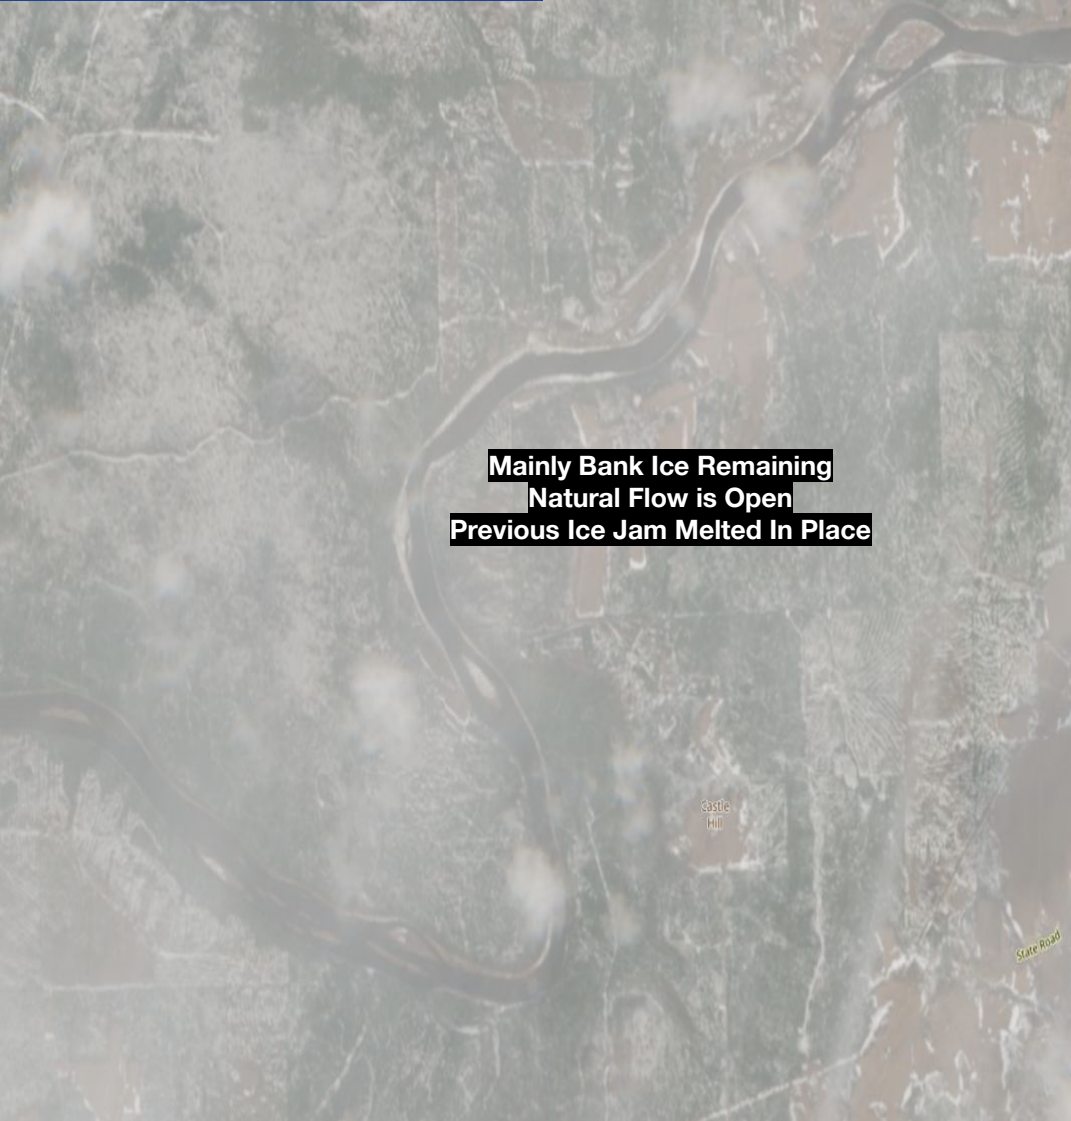
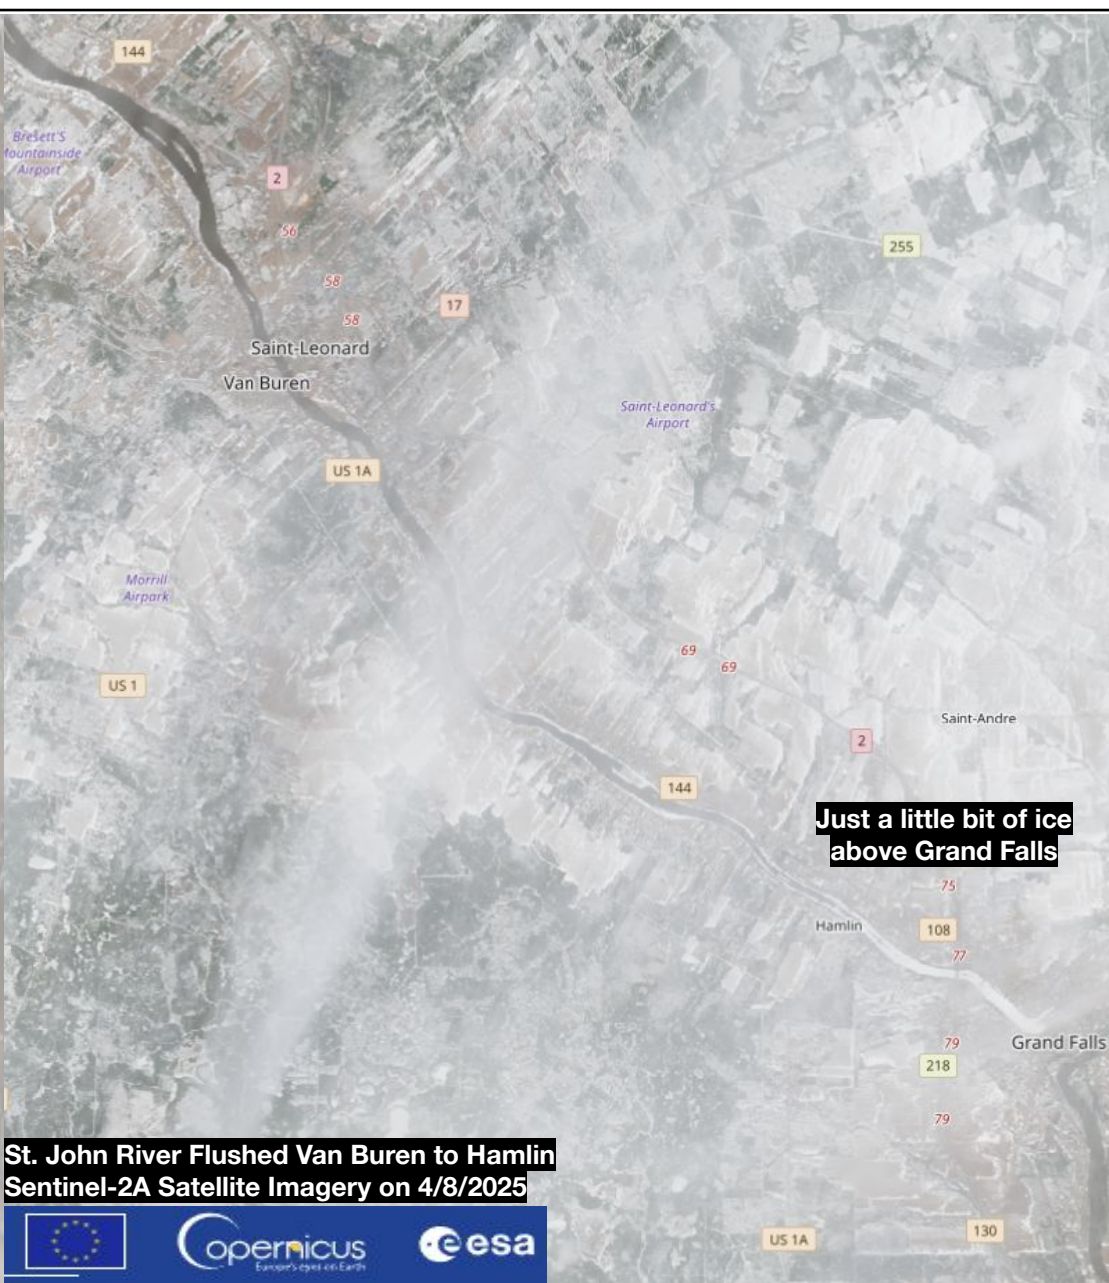
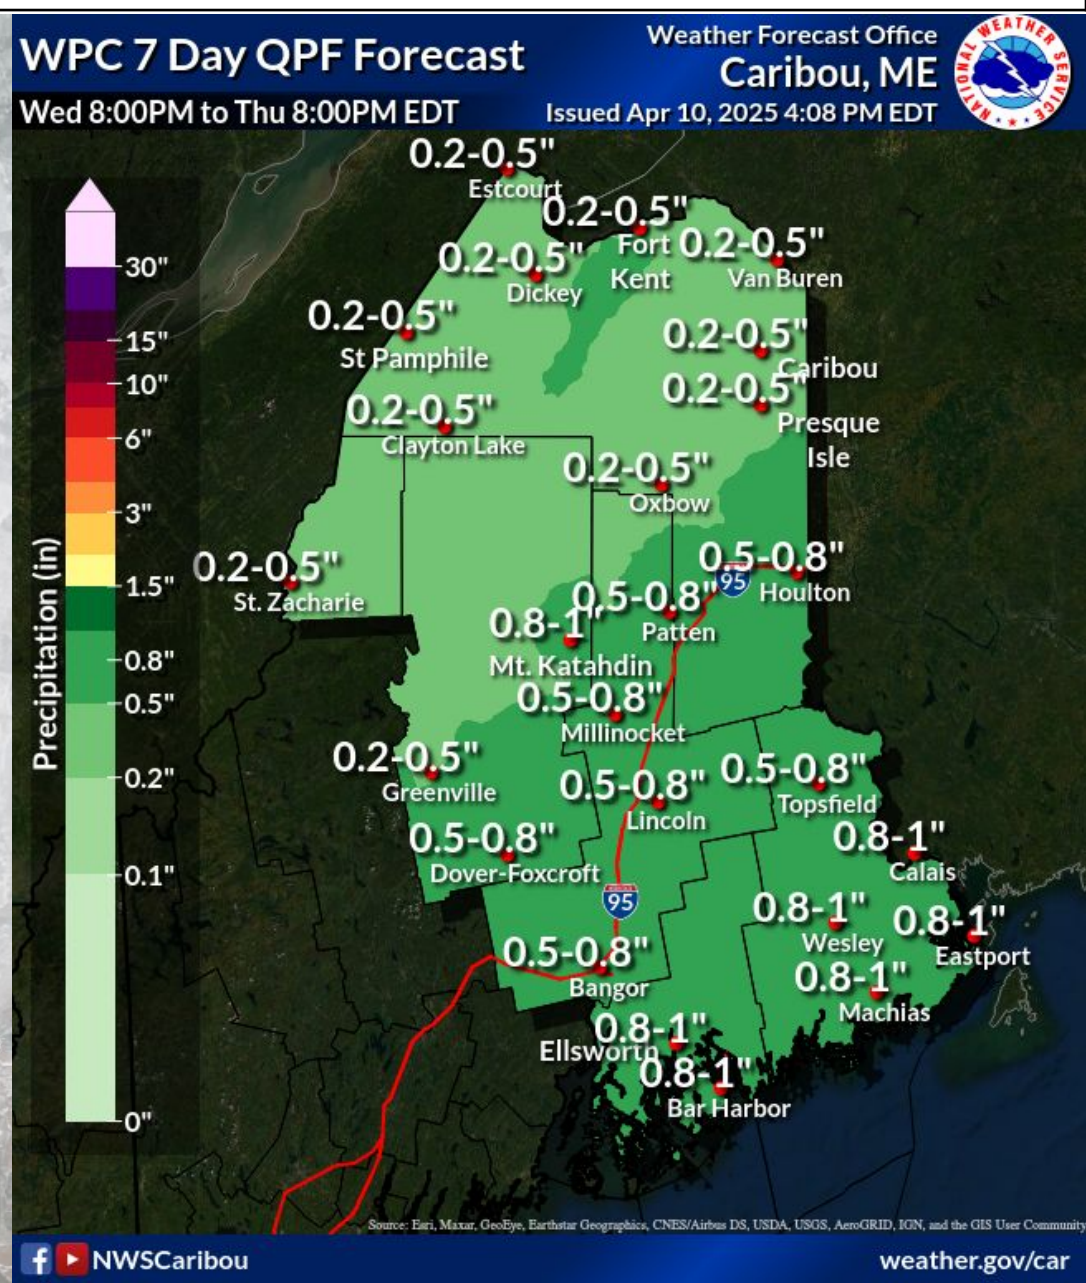
- **Northern Basins:** Ice has completely flushed from the St. John & Aroostook Rivers. Any remaining ice is left on banks rotting, posing no threats.
- **Central Highlands, Downeast to Bangor Basins:** No Ice.

Wade / Castle Hill Bend on Aroostook River
Sentinel-2A Satellite Imagery on 4/8/2025
